NATIONAL TECHNICAL UNIVERSITY OF ATHENS

The Oroville Dam 2017 Spillway Incident

Possible Causes and Solutions

Diploma Thesis

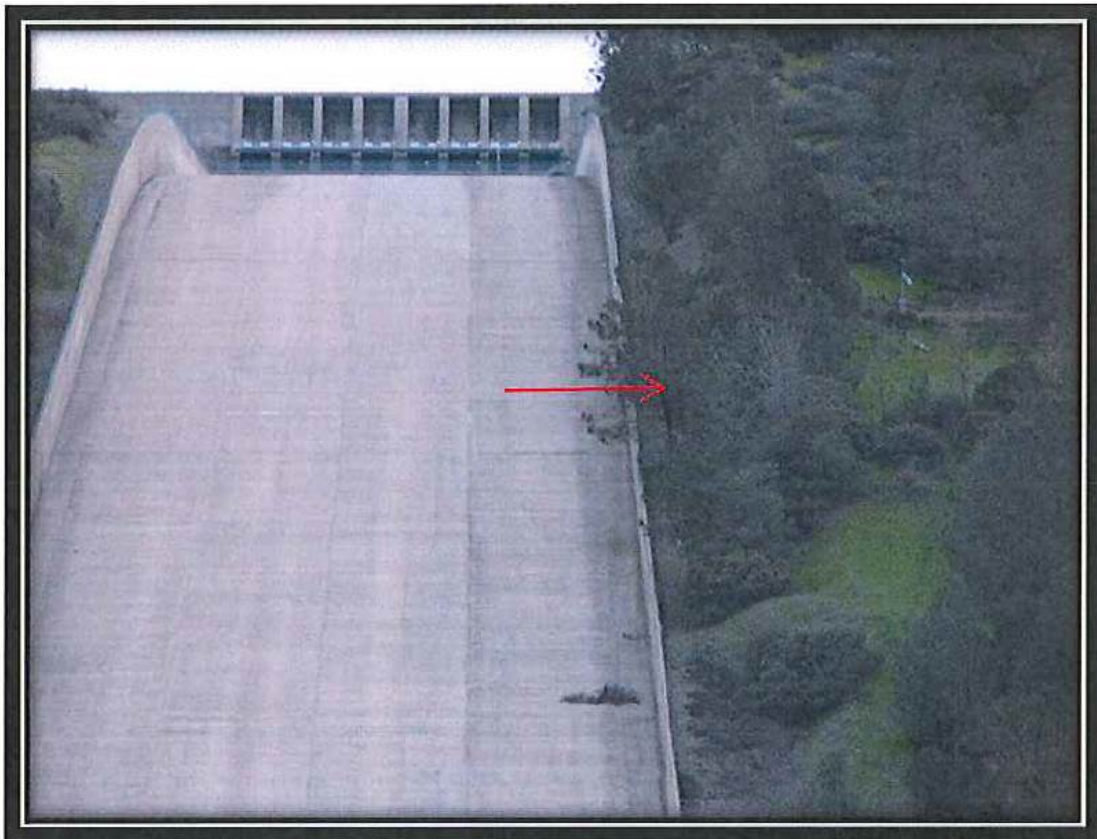
Image 15. August 3, 2015. A "lone tree" along the left wall of the Oroville Dam main spillway. Source: Division of Dam Safety, DWR.

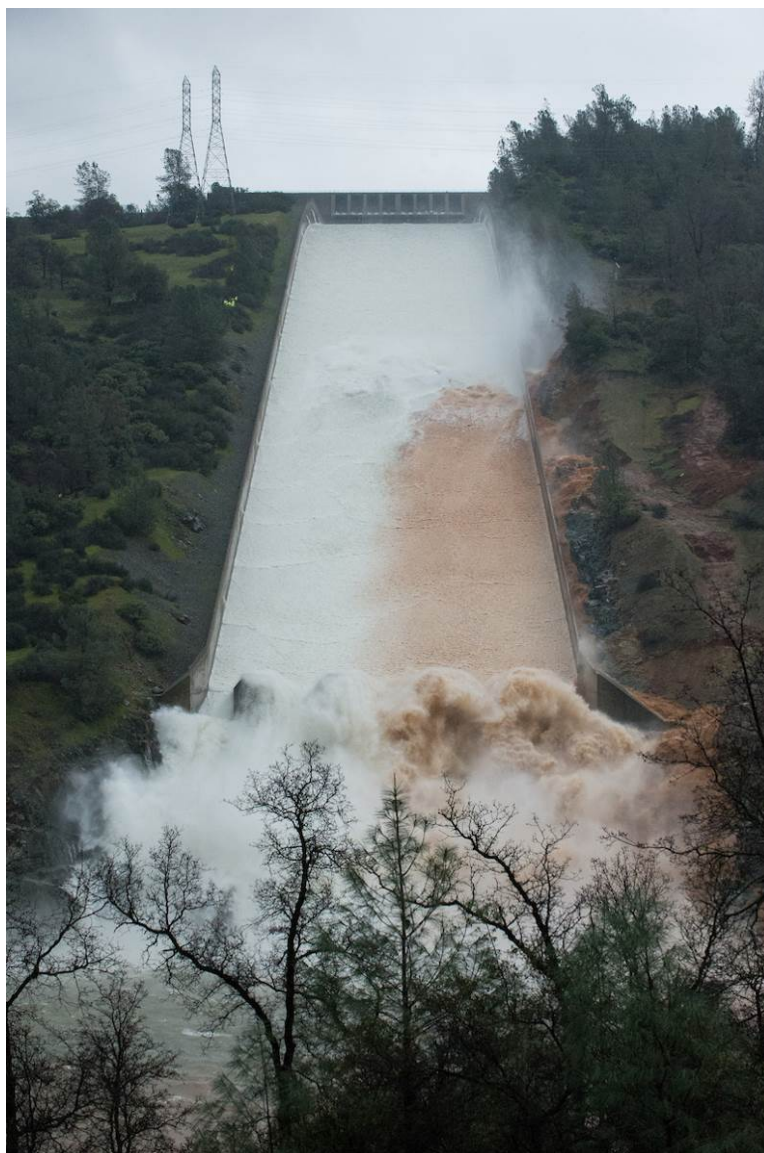
Image 16. February 8th, 2017. Discoloration of the flow along the Oroville Dam main spillway. Source: Kelly M. Grow, DWR.

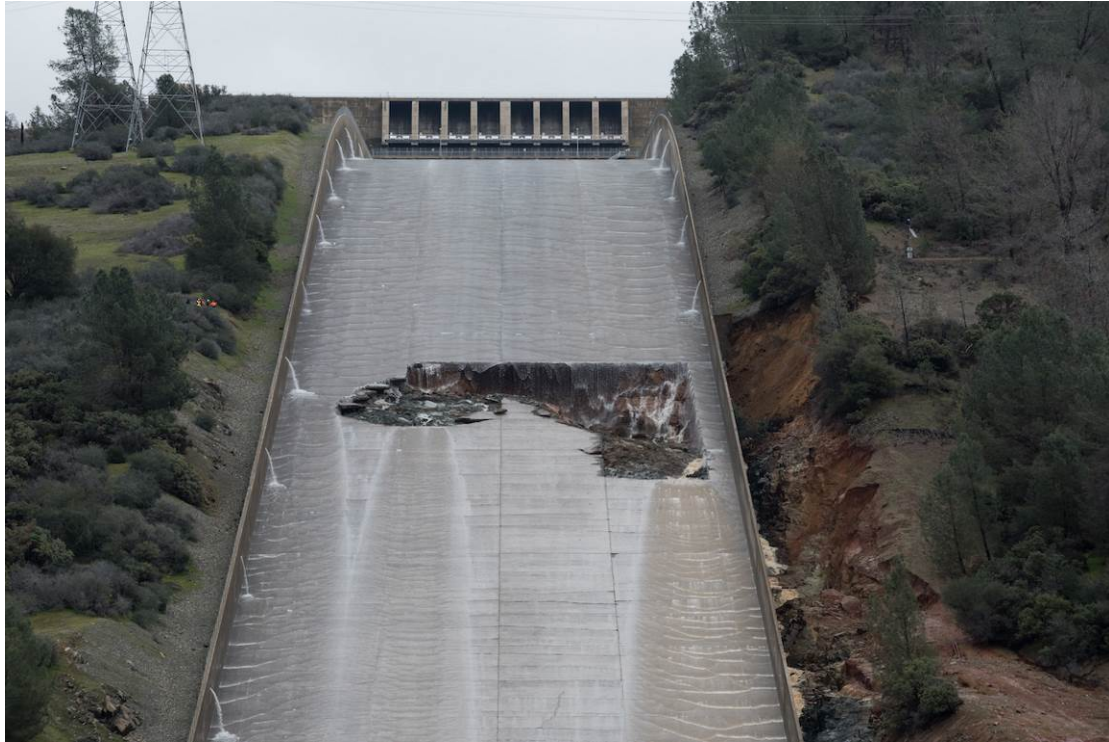
Image 17. February 7th, 2017. Front view of the initial main spillway chute damage. Source: Kelly M. Grow, DWR.

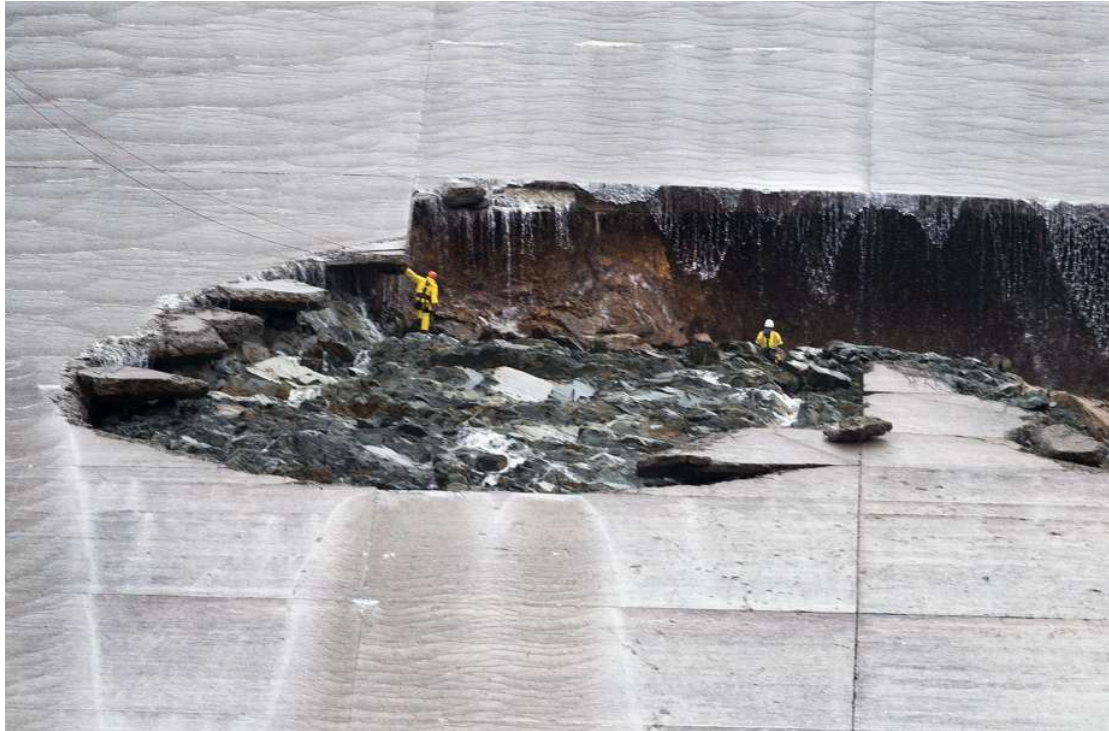
Image 18. February 7, 2017. Workers examining the ruptured Oroville Dam main spillway. Source: DWR.

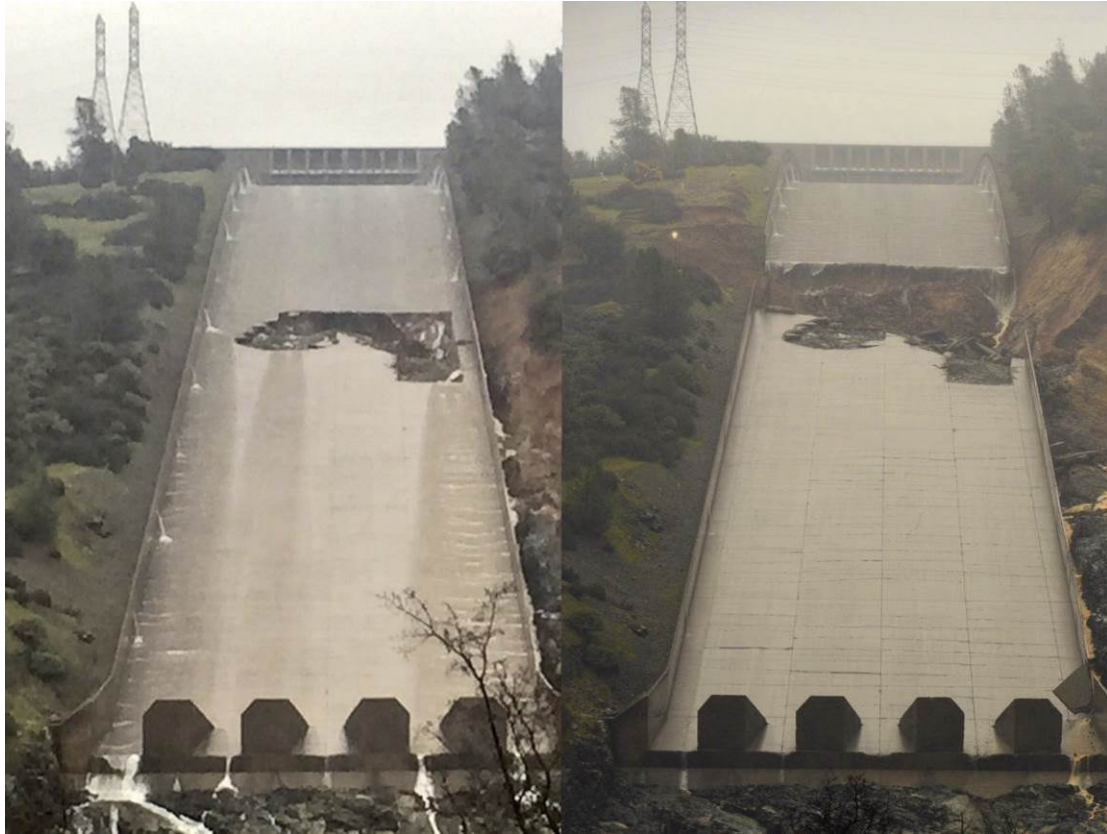
Image 19. Comparison of the February 7 main spillway hole (left) to the damage on February 9 (right). The erosion appears to be moving uphill. Sources: Kelly M. Grow, DWR and the Metabunk.org forum.

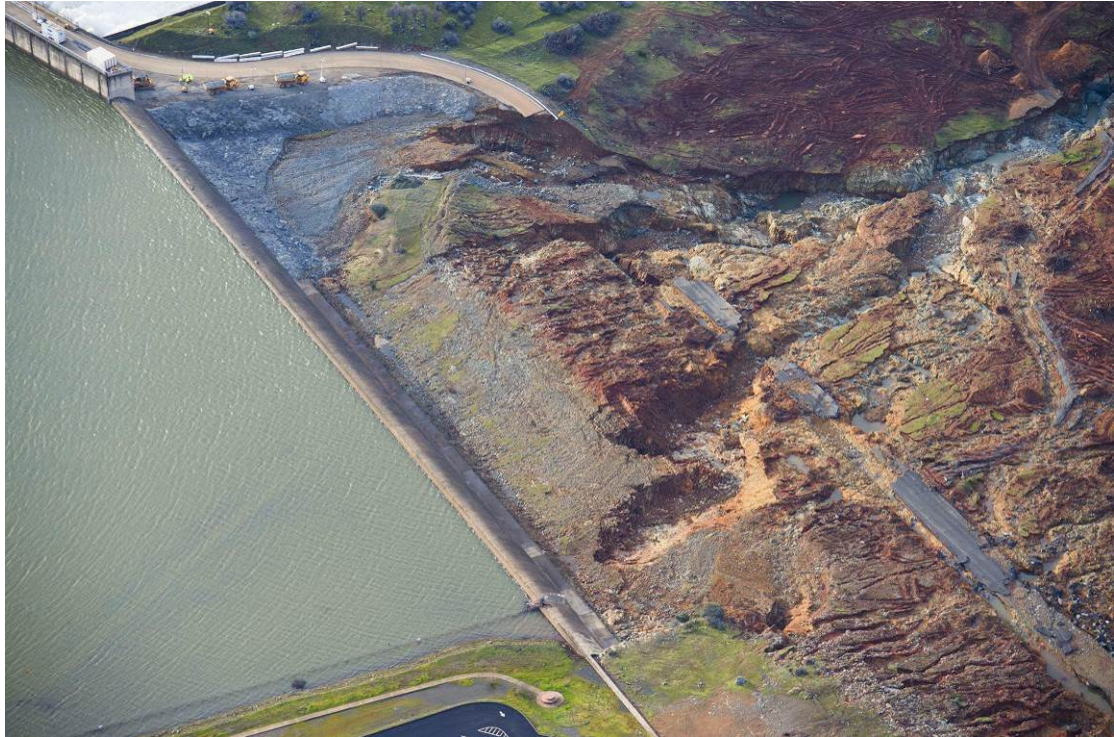
Image 23. February 13, 2017. The aftermath of the erosion caused by flows over the emergency spillway. Source: Randy Pench, Sacramento Bee.

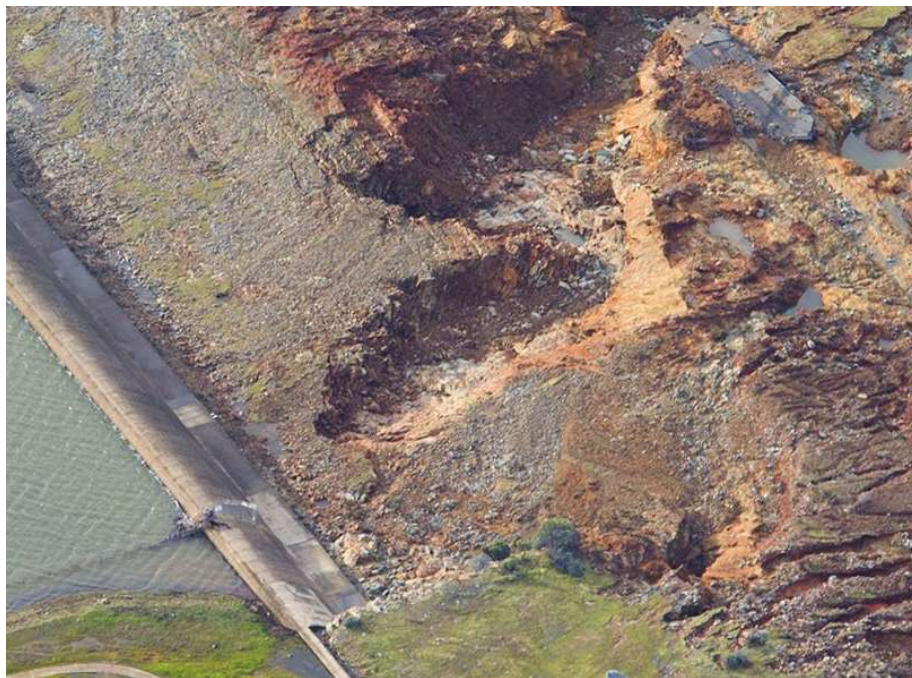
Image 24. February 13, 2017. Detail of a hole below the emergency spillway. Adapted from Randy Pench, Sacramento Bee.

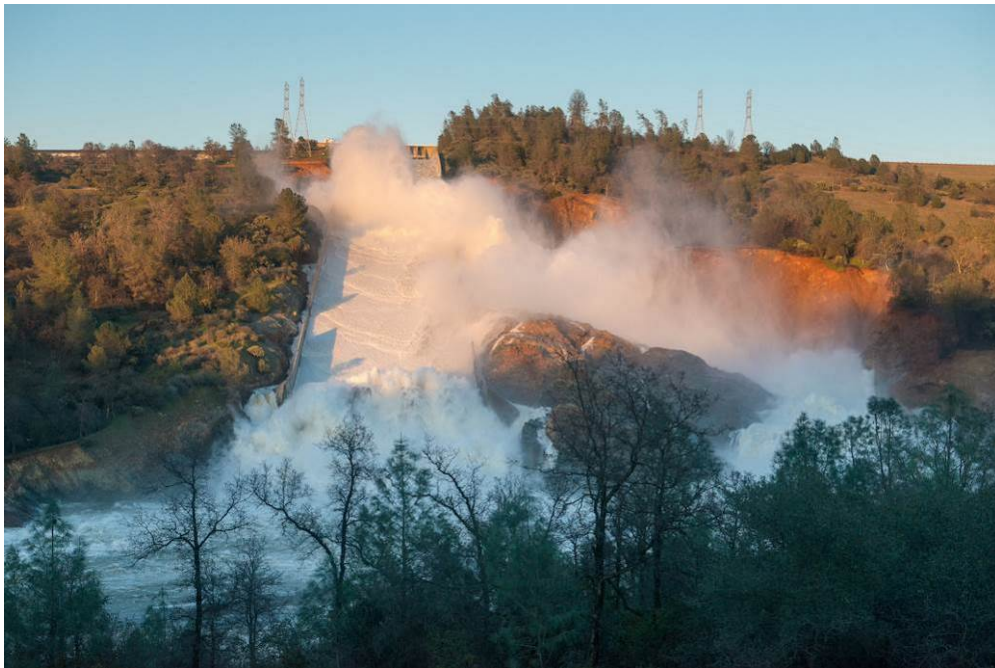
Image 26. February 11th, 2017. Water flowing over the damaged main spillway. Some of the discharge is flowing through the initial hole under the chute's left wall, creating a new channel. Source: Florence Low, DWR.

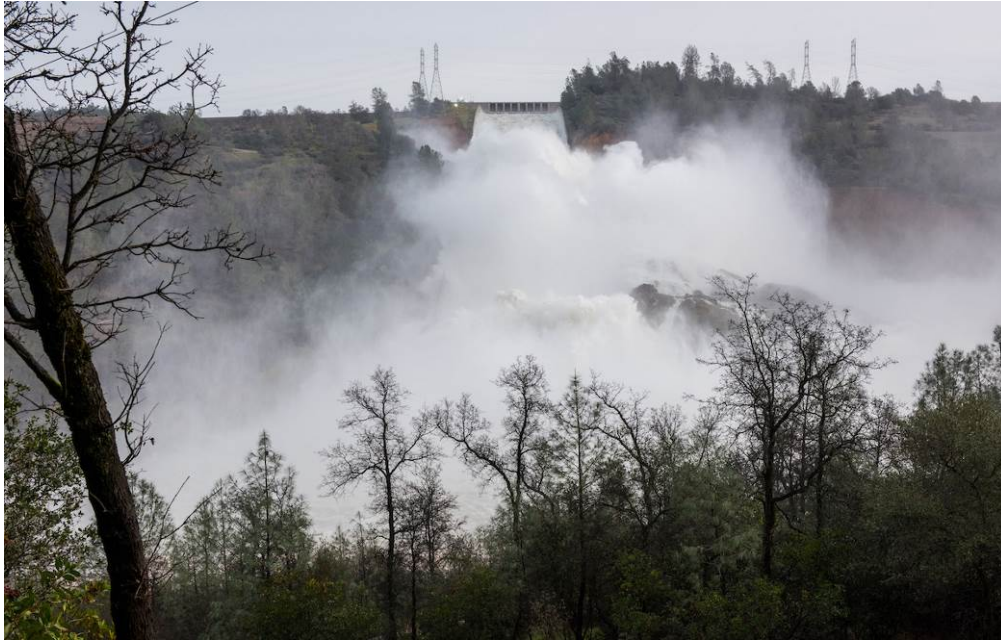
Image 27. February 13th, 2017. 2,830 m³/s (100,000 cfs) flowing over the main spillway. The chute's upper portion remains undamaged, but erosion quickly develops downstream. Source: Kelly M. Grow, DWR.

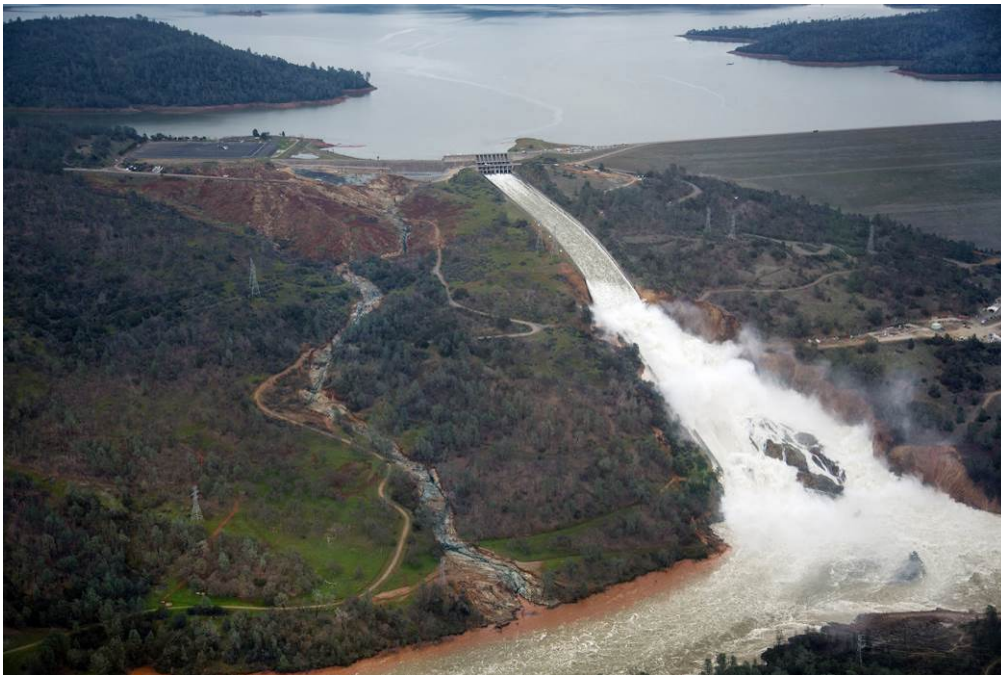
Image 28. February 15th, 2017. An aerial view of Oroville Dam's damaged spillways. Source: Dale Kolke, DWR.

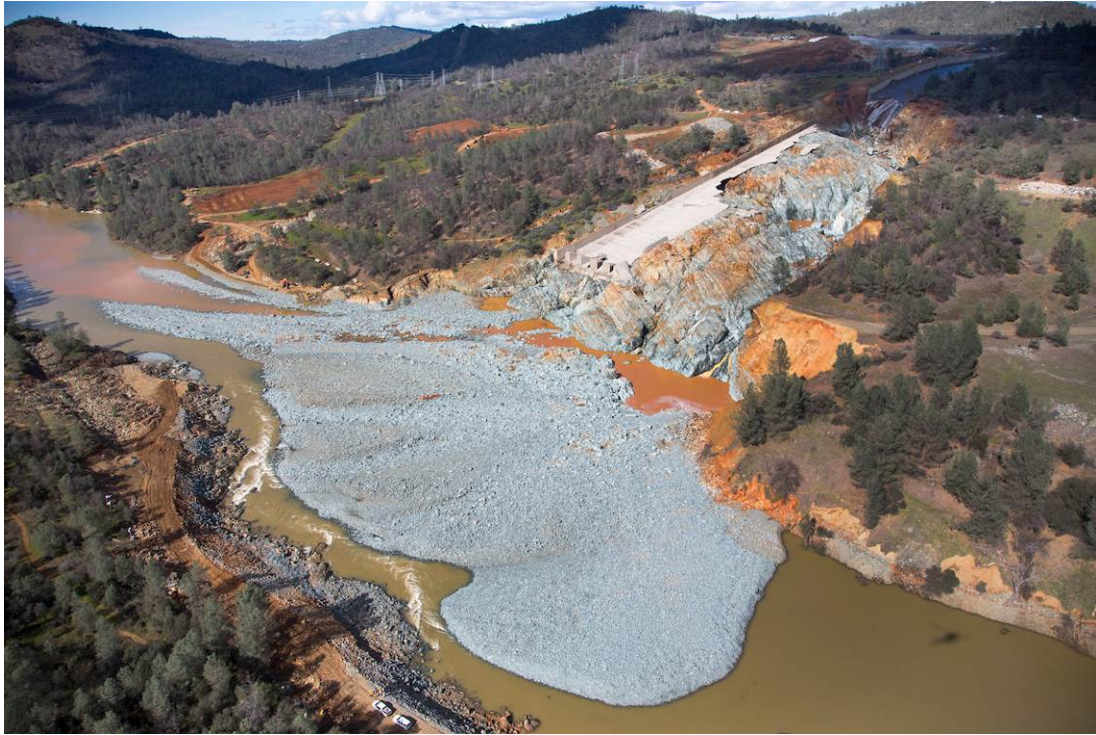
Image 30. February 27th, 2017. Aerial view of the Oroville Dam main spillway. Large sections have eroded away and ended up in the Feather River as debris. Source: Dale Kolke, DWR.

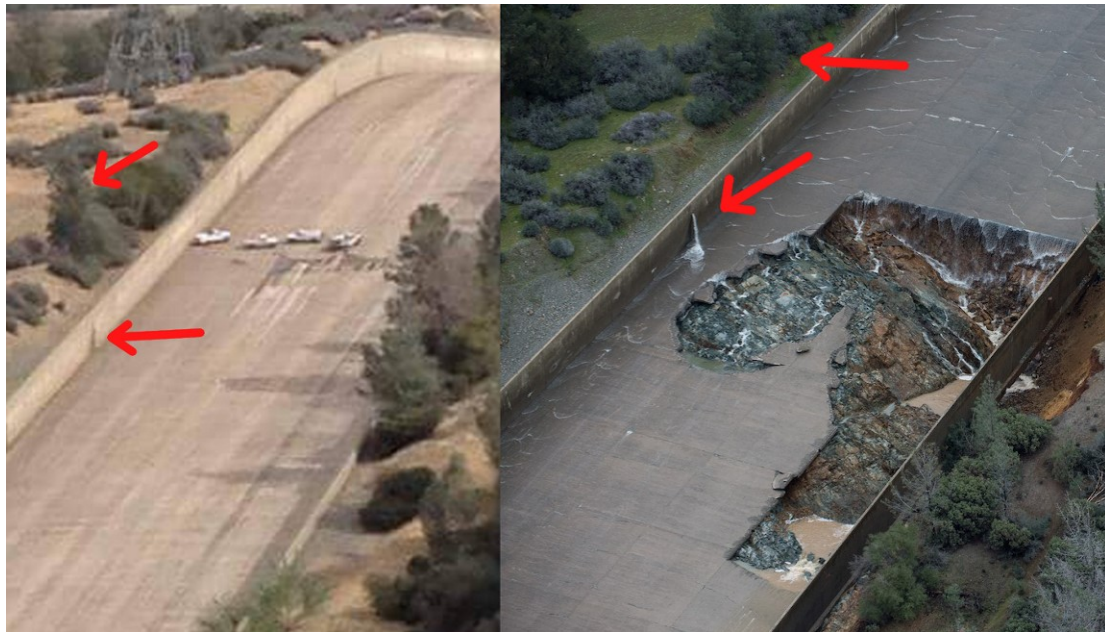
Image 37. Comparison of 2013 chute repairs and February 6th, 2017 initial chute damage. Sources: Unknown and Kelly M.Grow, DWR.

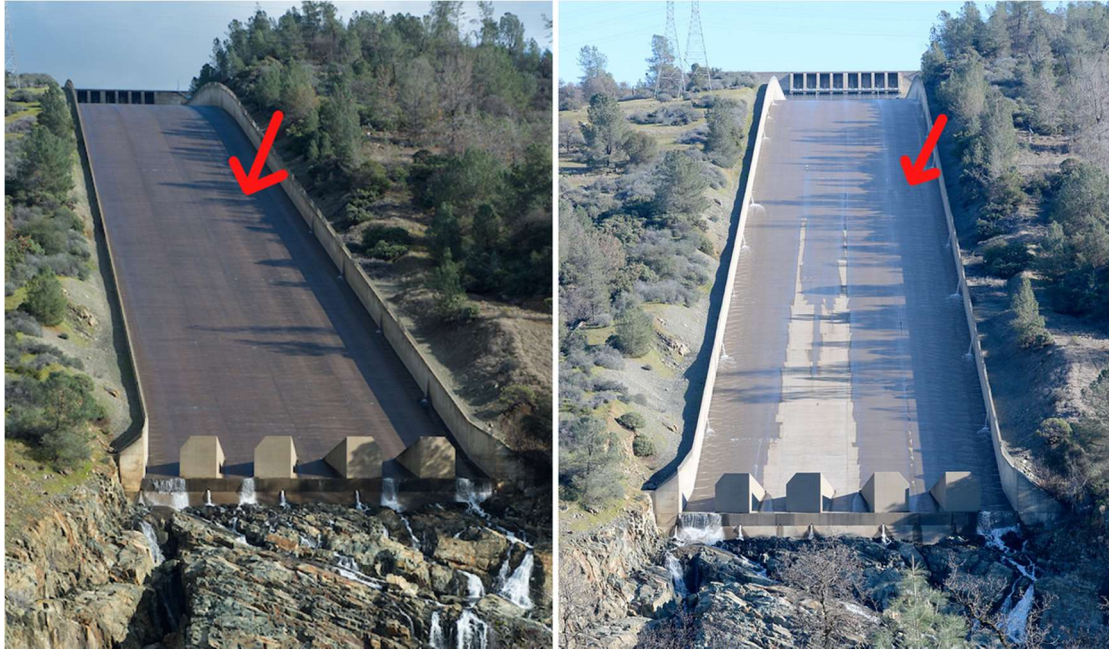
Image 38. Views of the Oroville Dam main spillway chute. Left photo taken January 11th, 2017, and right photo taken January 27th, 2017. A red arrow points to the location of the initial chute failure. Sources: Kelly M. Grow, DWR and Bill Husa, Chico Enterprise-Record.

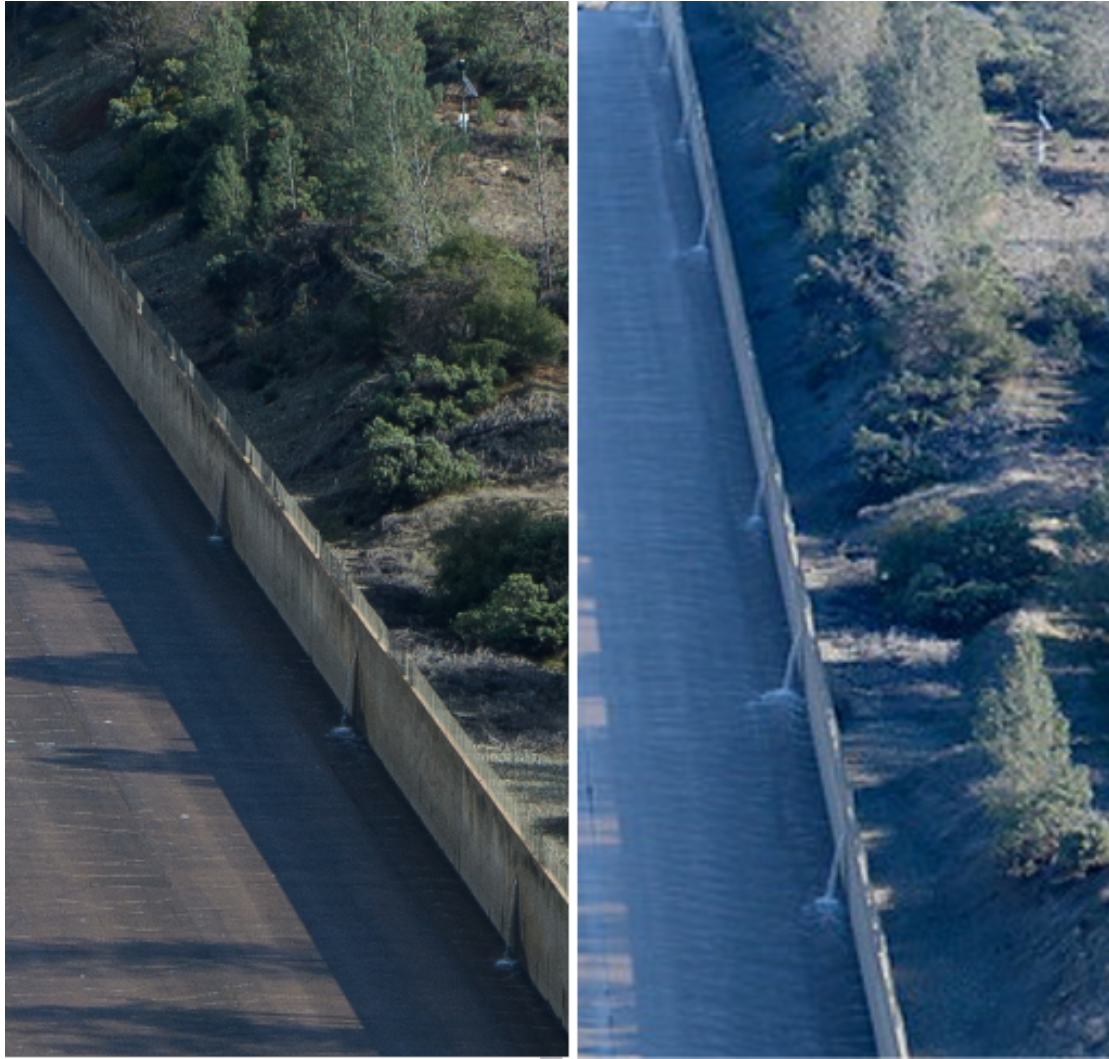
Image 39. Side by side comparison of drains in the spillway chute's left wall, left photo taken January 11, 2017 and right photo taken January 27, 2017. Sources: Kelly M. Grow, DWR and Bill Husa, Chico Enterprise-Record.

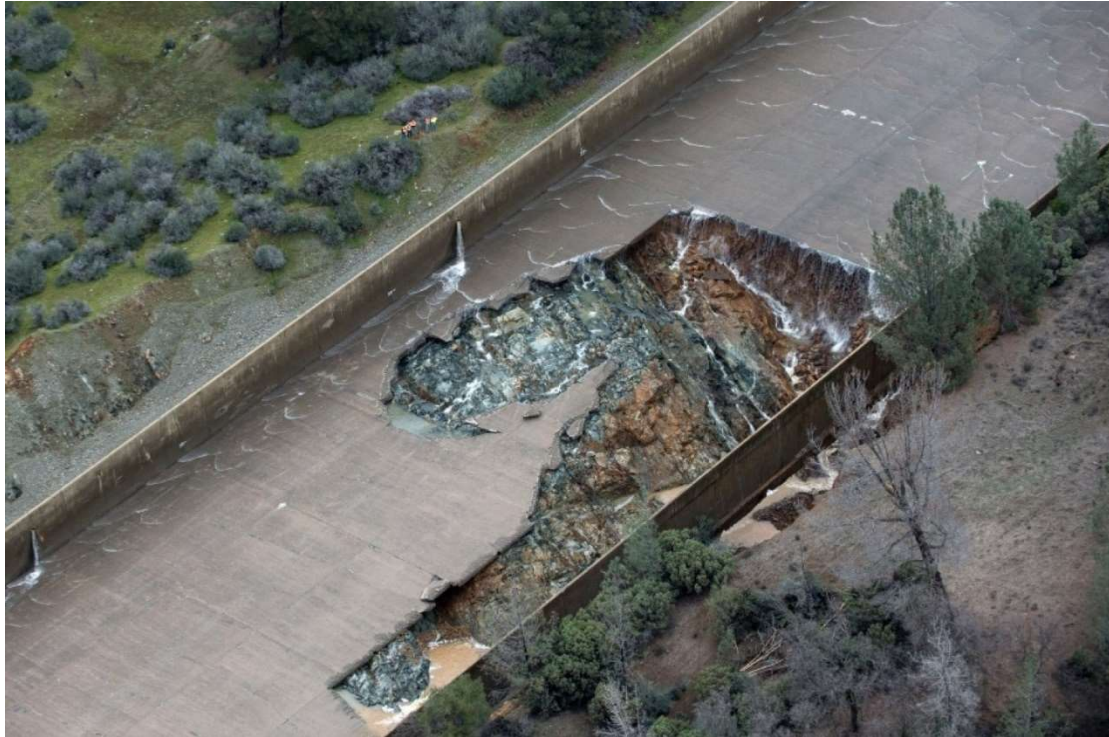
Image 40. February 7th, 2017. Side view of the initial spillway chute failure. Source: Kelly M. Grow, DWR.
