# Insights into the Oroville Dam 2017 Spillway Incident

**Abstract:** In February 2017, a failure occurring in Oroville Dam’s main spillway risked causing severe damages downstream. A unique aspect of this incident was the fact that it happened during a flood scenario well within its design and operational procedures, prompting research into its causes and determining methods to prevent similar events from reoccurring. In this study, a hydroclimatic analysis of Oroville Dam’s catchment is conducted, along with a review of related design and operational manuals. The data available allows for the comparison of older flood-frequency analyses to new alternative methods proposed in this paper and relevant literature. Based on summary characteristics of the 2017 floods, possible causes of the incident are outlined, in order to understand which factors contributed more significantly. It turns out that the event was most likely the result of a structural problem in the dam’s main spillway and detrimental geological conditions, but analysis of surface level data also reveals operational issues that were not present during previous larger floods, promoting a discussion about flood control d

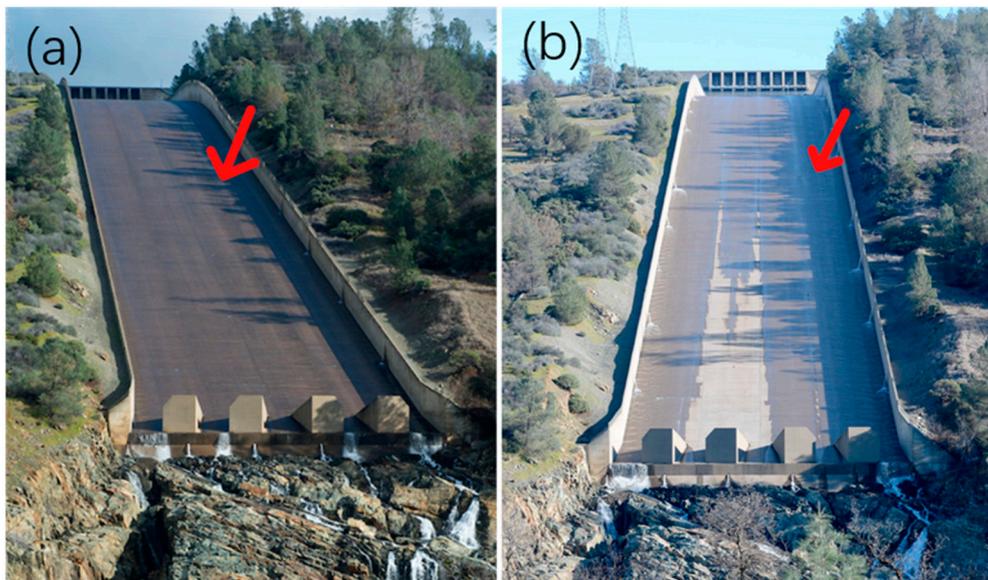
**Figure 5.** Views of the Oroville Dam main spillway chute. (a) taken on 11 January 2017, and (b) taken on 27 January 2017. A red arrow points to the location of the initial chute failure [38,51].

While these pictures were only taken within 16 days of each other, there are significant differences in the spillway chute. A center section of the chute's concrete floor appears dry on the right-hand picture, despite flows passing over the rest of the structure. This indicates possible irregularities among the floor slabs. Furthermore, the fact that this dry patch is not visible in the photo taken earlier, could possibly mean that a possible slab uplift occurred near the red arrow's location, diverting small water flows around it instead of over it.

Furthermore, by looking at the drain system more closely, two clues are revealed: First, water is coming out of the drains under pressure, which is not according to design specifications, and secondly, discharge from these drains significantly increased in a short time, once flows from the January flood filled up the Oroville Dam reservoir. This is a telltale sign of a buildup of excess water occurring beneath the spillway, which could apply significant forces to the concrete slabs from below and cause them to uplift [40]. Additionally, the January 27 photograph shows the drains on the opposite wall operating under pressure as well.
