INTERNATIONAL CONFERENCE ON SEWER SOLIDS CHARACTERISTICS,
MOVEMENT, EFFECTS AND CONTROL
5 - 8 SEPTEMBER 1995 ♦ DUNDEE, U.K

OCCURRENCE AND GENERAL CHARACTERISTICS OF DEPOSITS IN THE ATHENS STORM SEWERS

DEMETRIS ZARRIS AND DEMETRIS KOUTSOYIANNIS
DEPARTMENT OF WATER RESOURCES ♦ FACULTY OF CIVIL ENGINEERING
NATIONAL TECHNICAL UNIVERSITY OF ATHENS

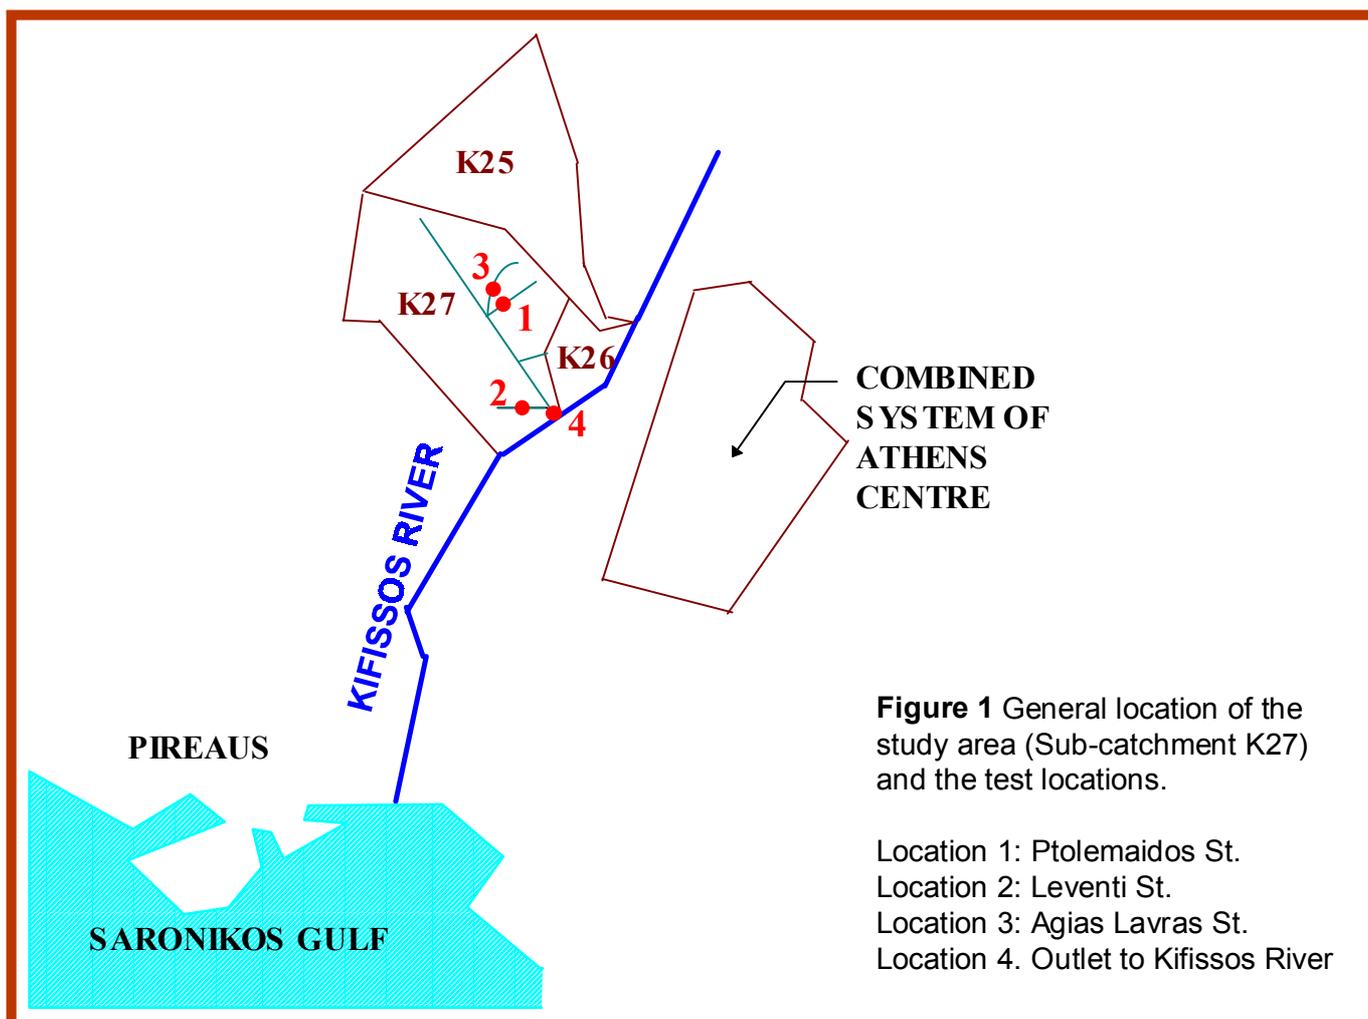
Four particular locations of the network have been investigated thoroughly twice in a two month period. The study area and the four locations are shown in Figure 1 below.

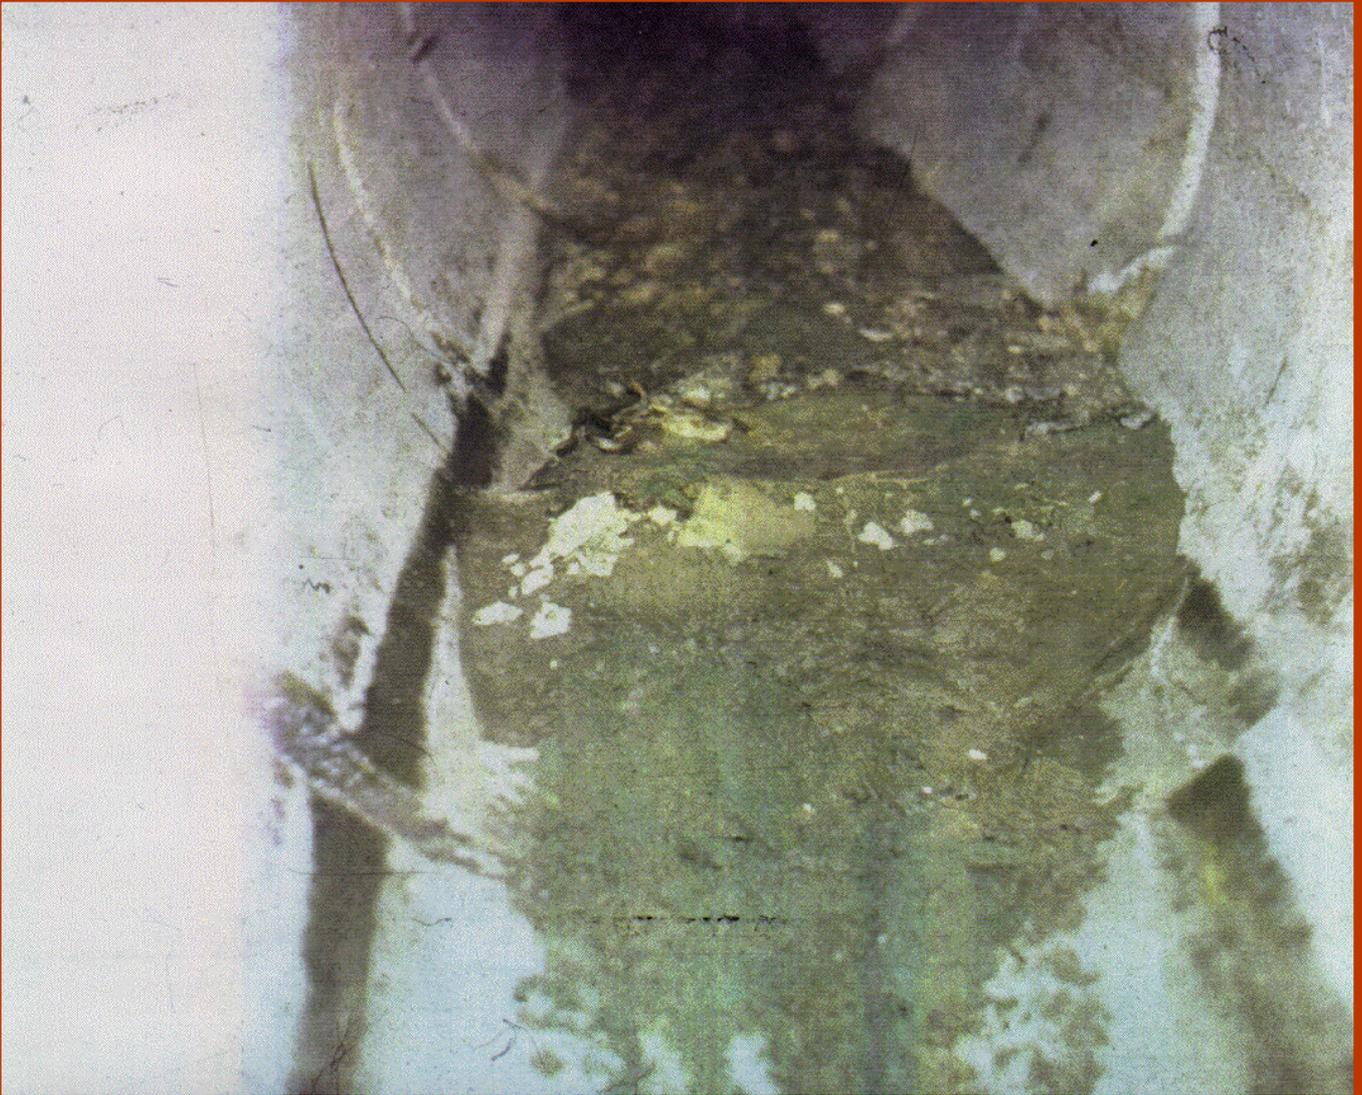
Figure 2 Deposit in the circular sewer at Leventi St., upstream of a sewer bend. Survey on 25/05/96.

- *Deposits from fine material at the downstream parts of the network* (30% of the total mass pass the 74 μm sieve). In two of the examined cases (Leventi St. and Agias Lavras St.) the deposits have impressively fine fractions (44 and 61.6% of the total mass respectively pass the 74 μm sieve). These deposits most likely have properties quite similar to the material known as “heavy fluid layer”. While the organic load of these deposits is generally high for storm sewers (more than 10% on average), the environmental damage at the start of a storm event (first flush) would be quite serious for the receiving waters, especially after a long preceding dry period.

- Upstream of sewer bends without the proper fitting to eliminate form energy losses.
- Upstream of locations where the sewer cross section widens downstream.
- Upstream of locations where the sewer slope decreases downstream.
- At the outlets where there is no a hydraulic drop of the outlet sewer to the receiving waters.
- Upstream of a confluence with a more significant flow such as a major urban watercourse.
- Under low sewer slopes (generally less than 4 m/km).

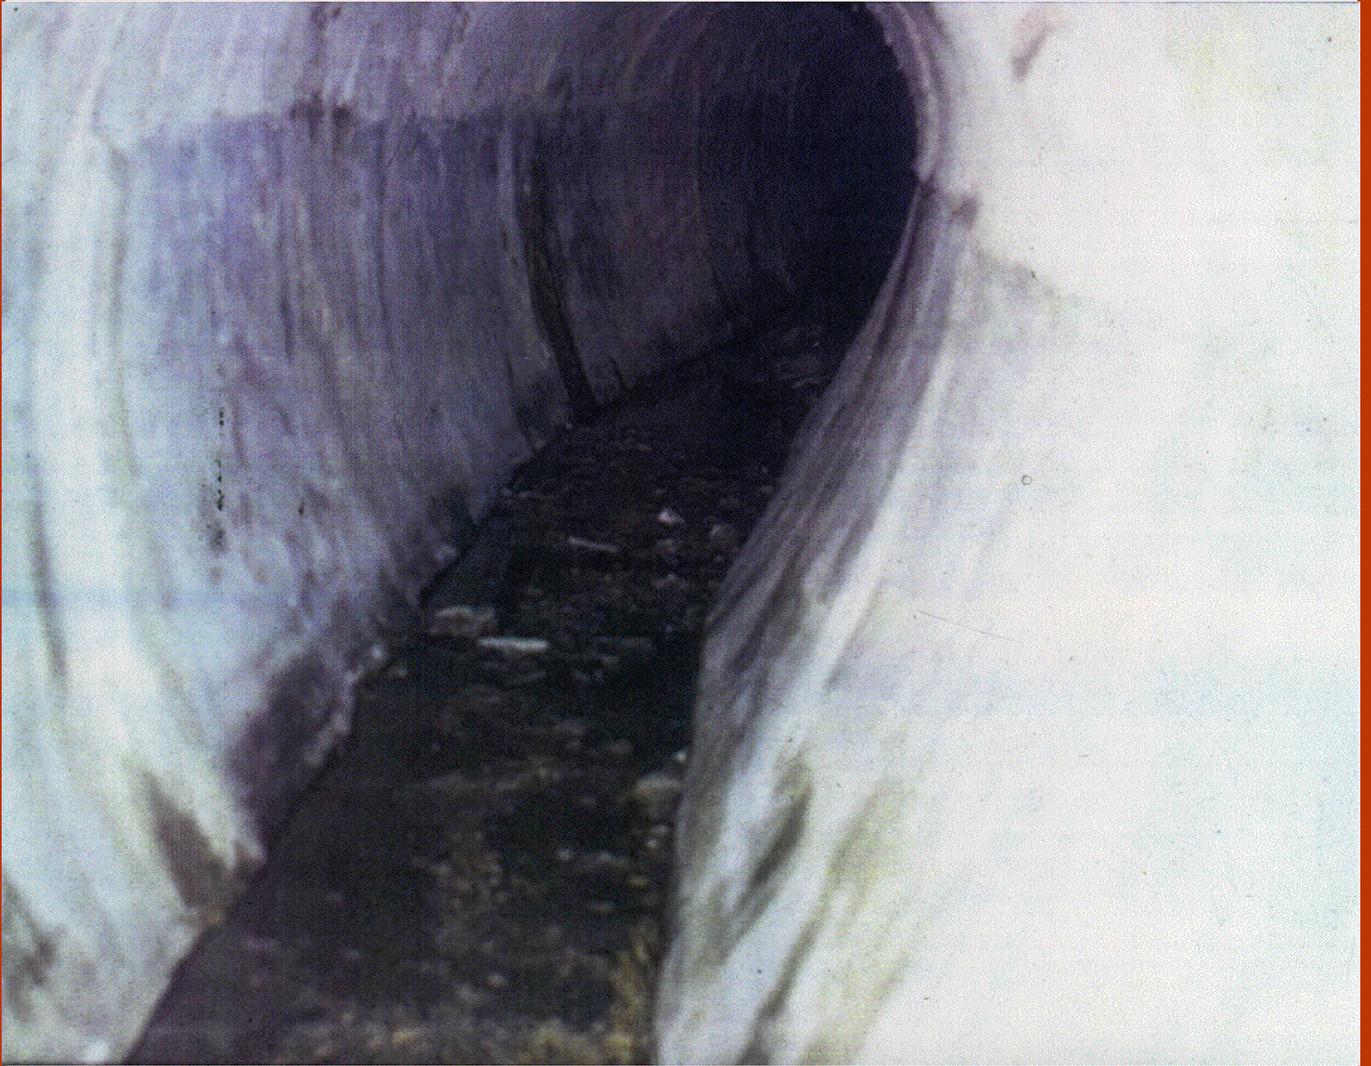
Figure 3 Coarse granular deposit in the egg shaped sewer at Ptolemaidos St., upstream of a sewer bend. Survey on 25/05/96.

- *Deposits from coarse and granular material at the upstream parts of the network* (more than 95% of the total mass consists of sand and gravel). As shown in Figure 5 there is no apparent stratification of the particle sizes on the entire depth of the deposit. After an intense rainfall the deposit surface was rough with a random appearance (without any regular form such as ripples or dunes). After a period of two months from the first survey when the preceding rainfall was modest this surface became plain.

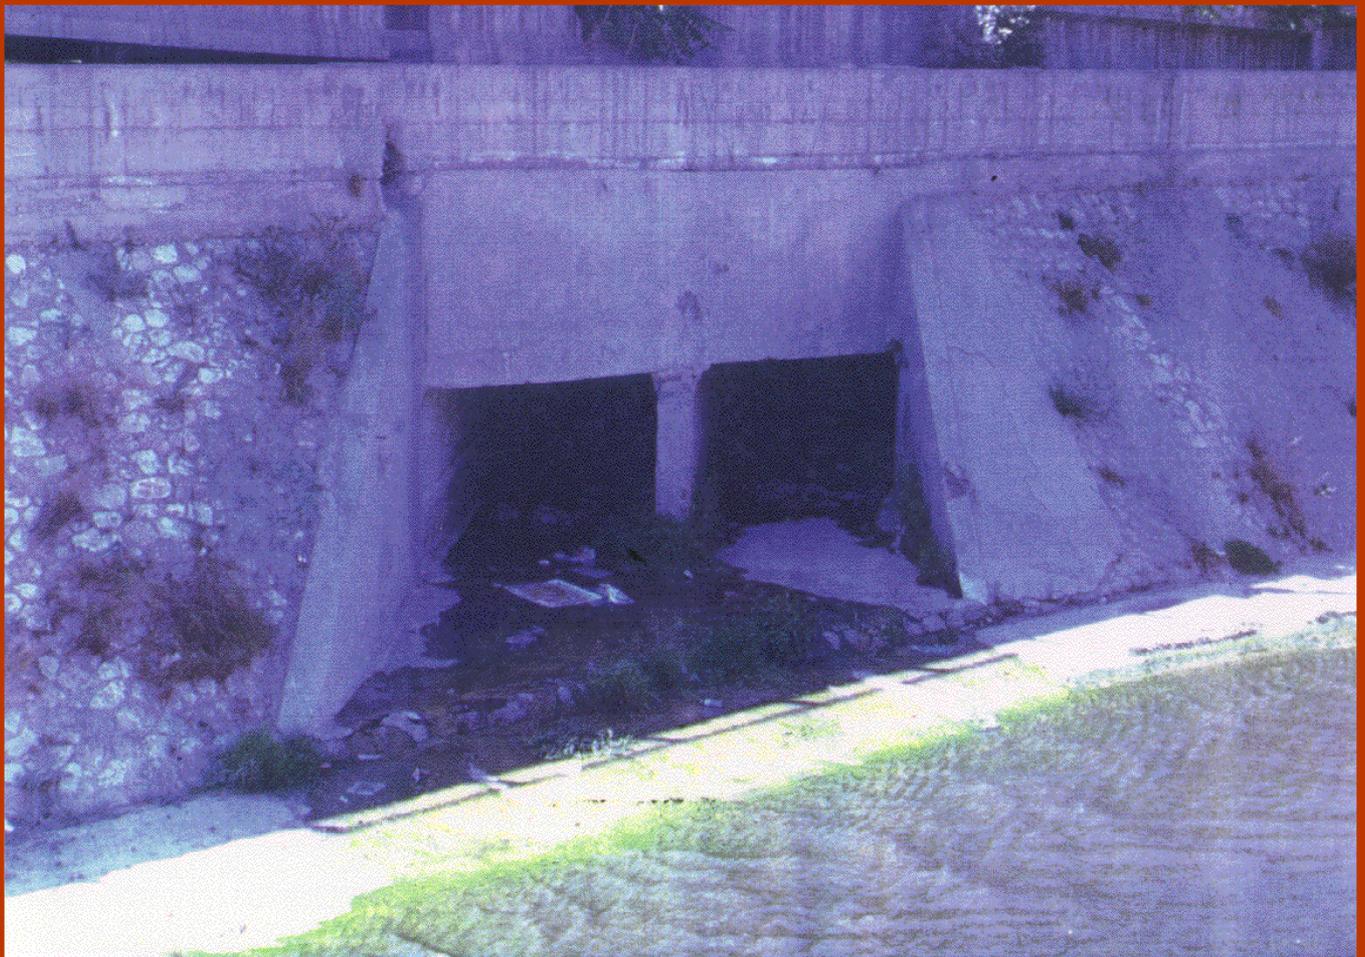
Figure 4 Fine thick (50 cm) deposit in the outlet of the K27 sewer to the Kifissos River. Survey on 25/05/96. The outlet is submerged during intense floods of the Kifissos River.

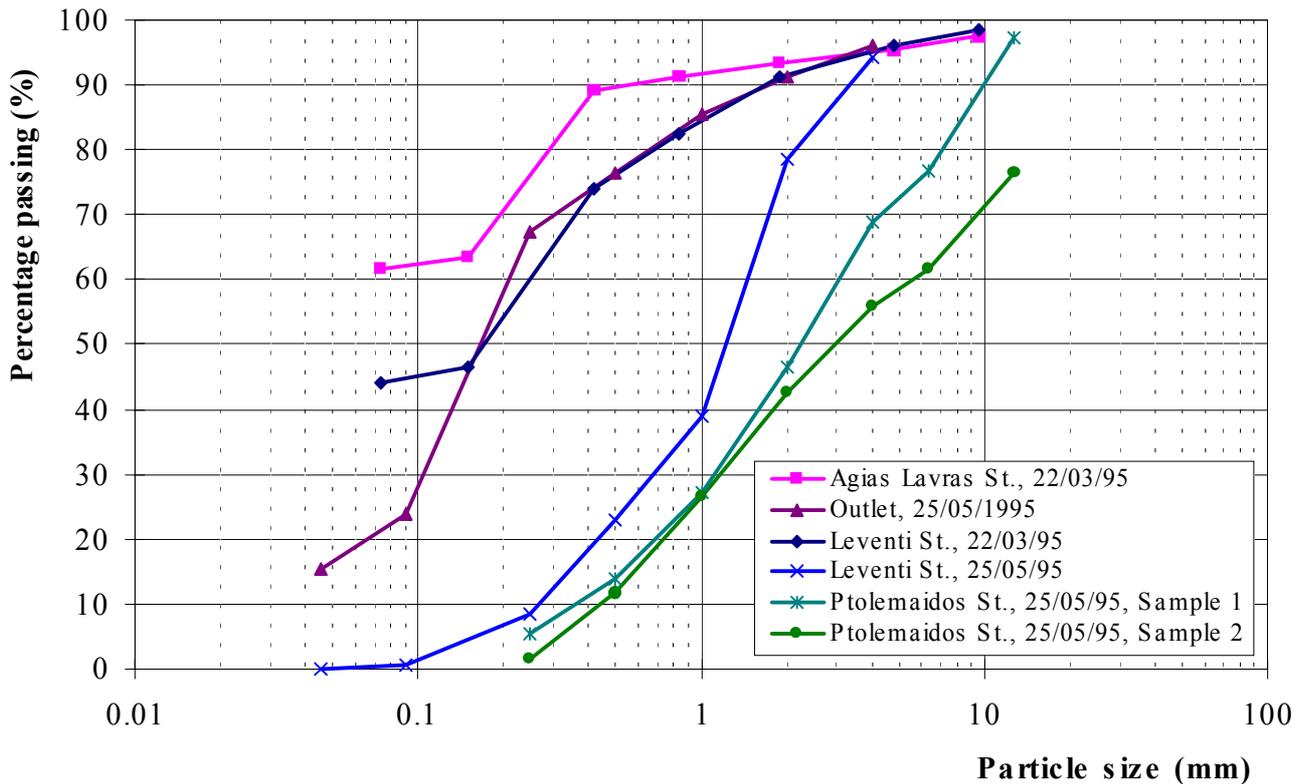
The in situ investigation has shown that deposits are very serious as their depths in large interceptor sewers exceed 50 cm in depth. Four cases of deposits have been sampled and analysed in laboratory. The properties of the solids of the deposits are given in the Table 2 below. The results of the granulometric sieving are given in Figure 5.

Figure 5 Granulometric analysis of the deposit samples. Notable is the existence of two categories, coarse-granular and fine. Also notable is the change of the deposit characteristics at Leventi St. from fine to coarse during a two month interval. Sample 1 of Ptolemaidos St. comes from the upper part of the deposit near the surface, while Sample 2 is from the lower part near the invert.
