# **Flooding in Athens: The Kephisos River flood event of 21-22/10/1994**

## **Short description of the event**

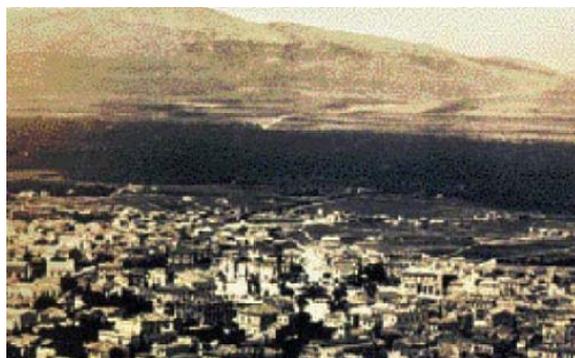
*Fig. 1: Western Athens (1870)*  
(Source: Laskaris 2008)

The urbanization of the western Attika caused an obvious socio-economic segregation in the population of Athens, something that was not mitigated as times went by. In Figures 1 and 2 the extensive urbanization that took place in the last 137 years around the river can be observed.

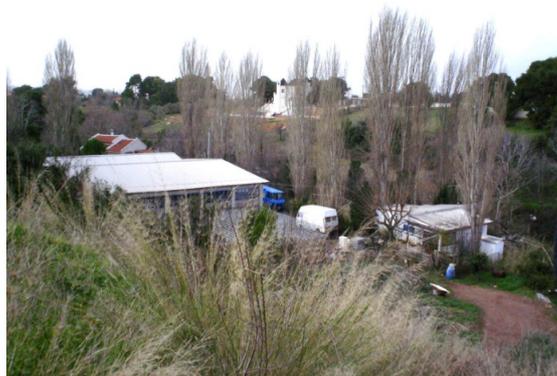
*Fig. 3: Structures on river bed  
(Source: Laskaris 2008)*

Nowadays, the built-up area of the Kephisos river catchment amounts to the 70% of its total extent, while this percentage is supposed to get increased in the future. In the following figures, typical examples of arbitrary construction activity are presented.

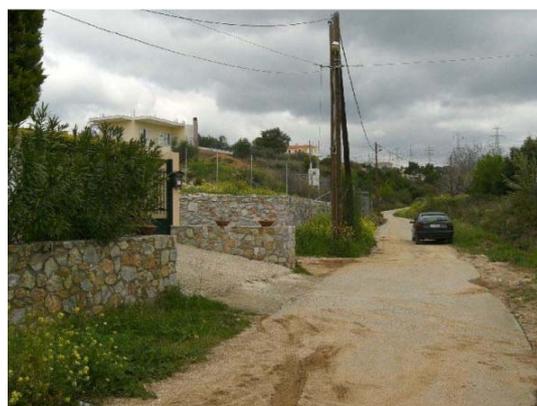
*Fig. 4: Roads and houses on streambeds  
(Source: Laskaris 2008)*

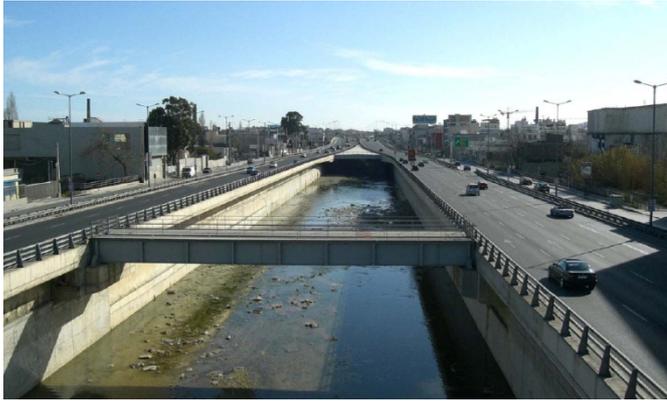
*Fig. 5: Combination of the drainage channel with Kephisos Avenue (Source: Laskaris 2008)*

- From «Treis Gefures» up to «Agia Anna», the river is fully covered and upon the river Kifissos avenue has been constructed, as shown in figure 5.
- The river section profile is of «open form» from «Agia Anna» up to «Posidonos» Avenue

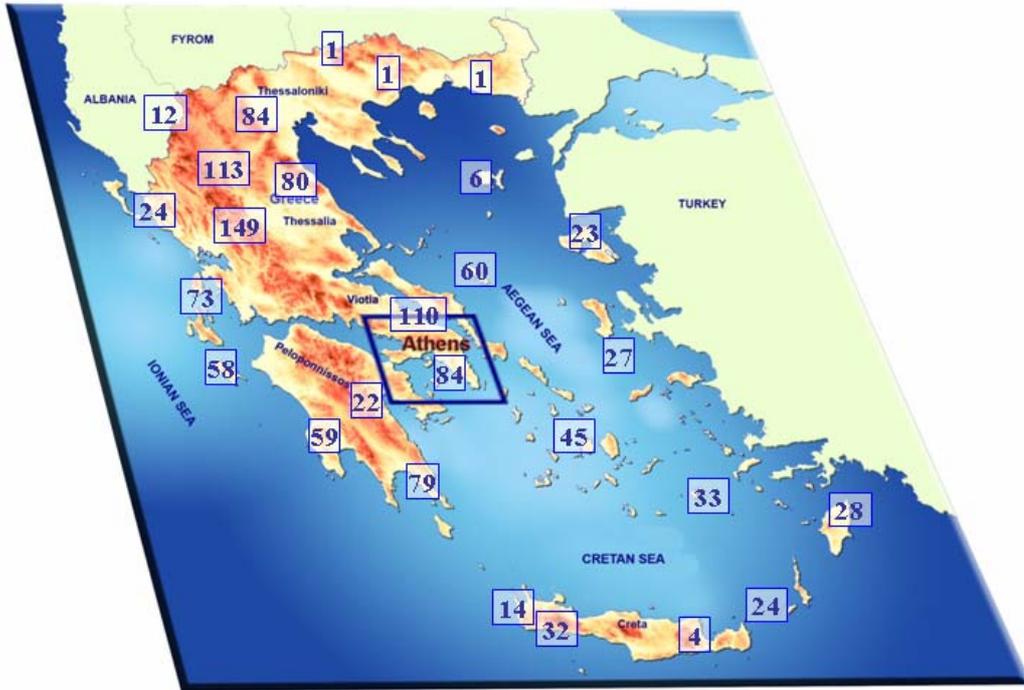
Fig. 7: Geographical distribution of 24 h precipitation in Greece (from 21/10/1994 06 UTC to 22/10/1994 06 UTC)

At 21/10/1994 00 UTC a low center (999 hPa) was situated over the Gulf of Genoa. The cyclonic propagated eastward and 12 hours later was deepened (996 hPa) and it was installed over southern Italy (Figure 6). At 21/10/1994 18 UTC the low center was further deepened (994 hPa) while a cold front associated with the low center has progressed toward the Ionian Sea. During October 21-22, 1994 the cold front passed over Greece and provoked extreme precipitation in several regions. In Figure 7, the geographical distribution of 24 h precipitation (from 21/10/1994 06 UTC
