Documenting the Changing Floodplain of Nileas Basin in North Euboea (Greece) before and after Storms Daniel and Elias

Keywords: Hydraulics; On-site inspections; Floods; Plane trees disease; Wildfires

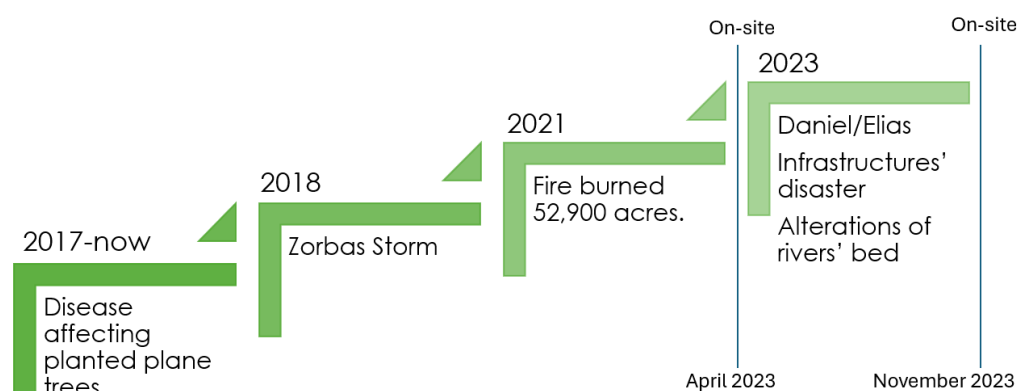
Figure 1. The steps of the issues of the disaster and on-site inspections.

The first on-site inspections took place in April 2023 and after the following flood events (Daniel/Elias storms), we decided to follow up with a second on-site inspection in the Nileas River basin in November 2023 (Figure 1).

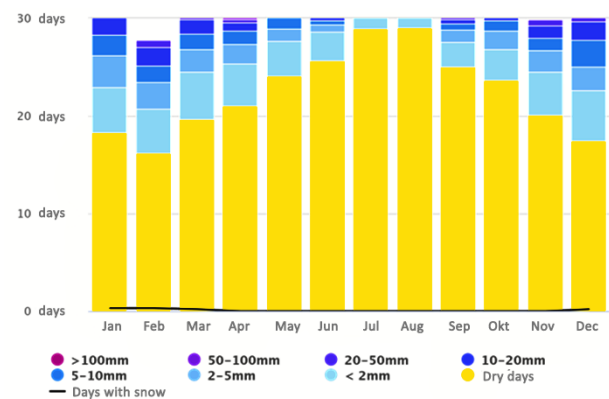
Figure 2. (a) The location of North Euboea (red dot) in Greece [10]; (b) Simulation of historical climate and weather data (source: [4] after adaptation).

The study area includes the Nileas River, and parts of the Kireas and Voudouros rivers. The region experiences a temperate climate with distinct rainfall patterns (Figure 2b), namely a decrease of rainfall is observed in the summer months, followed by an increase from September to April.

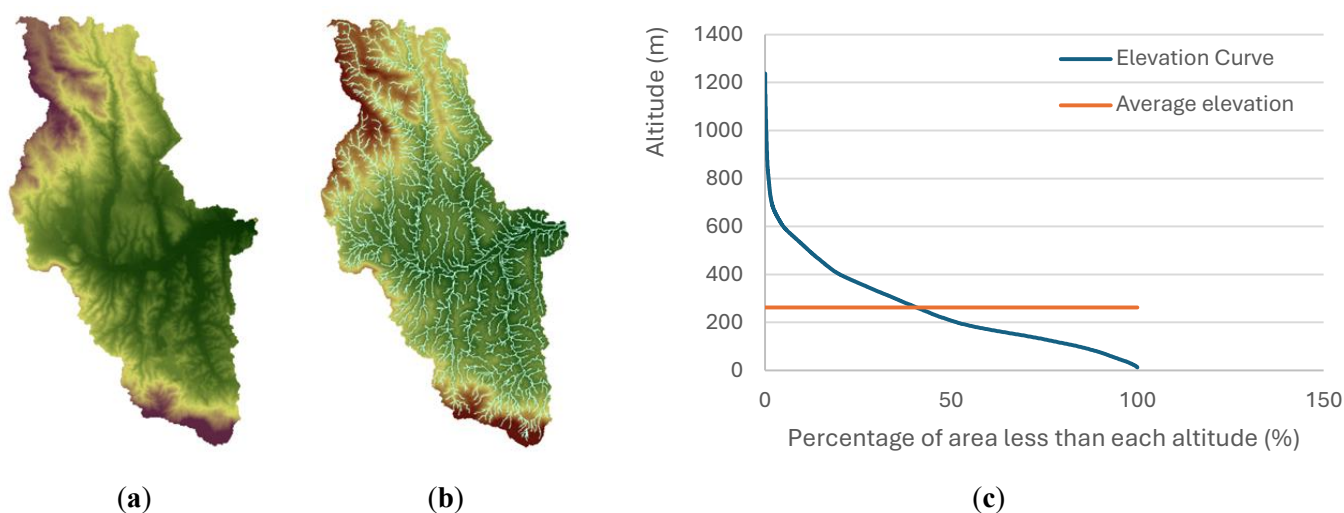
Figure 3. (a) The river basin of Nileas River; (b) hydrographical network (c) elevation curve.

The morphological characteristics of the basin area of Nileas River (Figure 3) are summarized in Table 1 and are mainly derived from Digital Elevation Model and national databases. The river basin of Nileas River provides an overview of the geographical study area, since all hydrological processes occur inside the river basin's boundaries. The hydrographical network illustrates the detailed river network within the Nileas River basin, including main rivers and tributaries, which is essential for analyzing how water flows and accurate flood modelling. Also, the river connectivity influences the distribution and health of flora in the riverbeds.

Both river basin and hydrographic network are derived from Digital Elevation Model following GIS procedures and then cross-checked with national geodatabases [11]. The elevation curve depicts the distribution of elevations inside the Nileas River basin, which is crucial for comprehending how variations in topography influence microclimate, water flow dynamics, and, subsequently, the ecological conditions, the plant communities, and flood risks throughout the basin. Part of the land is cultivated by the locals [12].

Basin area	184.45 km ²
Minimum elevation	13 m
Maximum elevation	1237 m
Average altitude	261.845 m
Length of mainstream	21.4 km

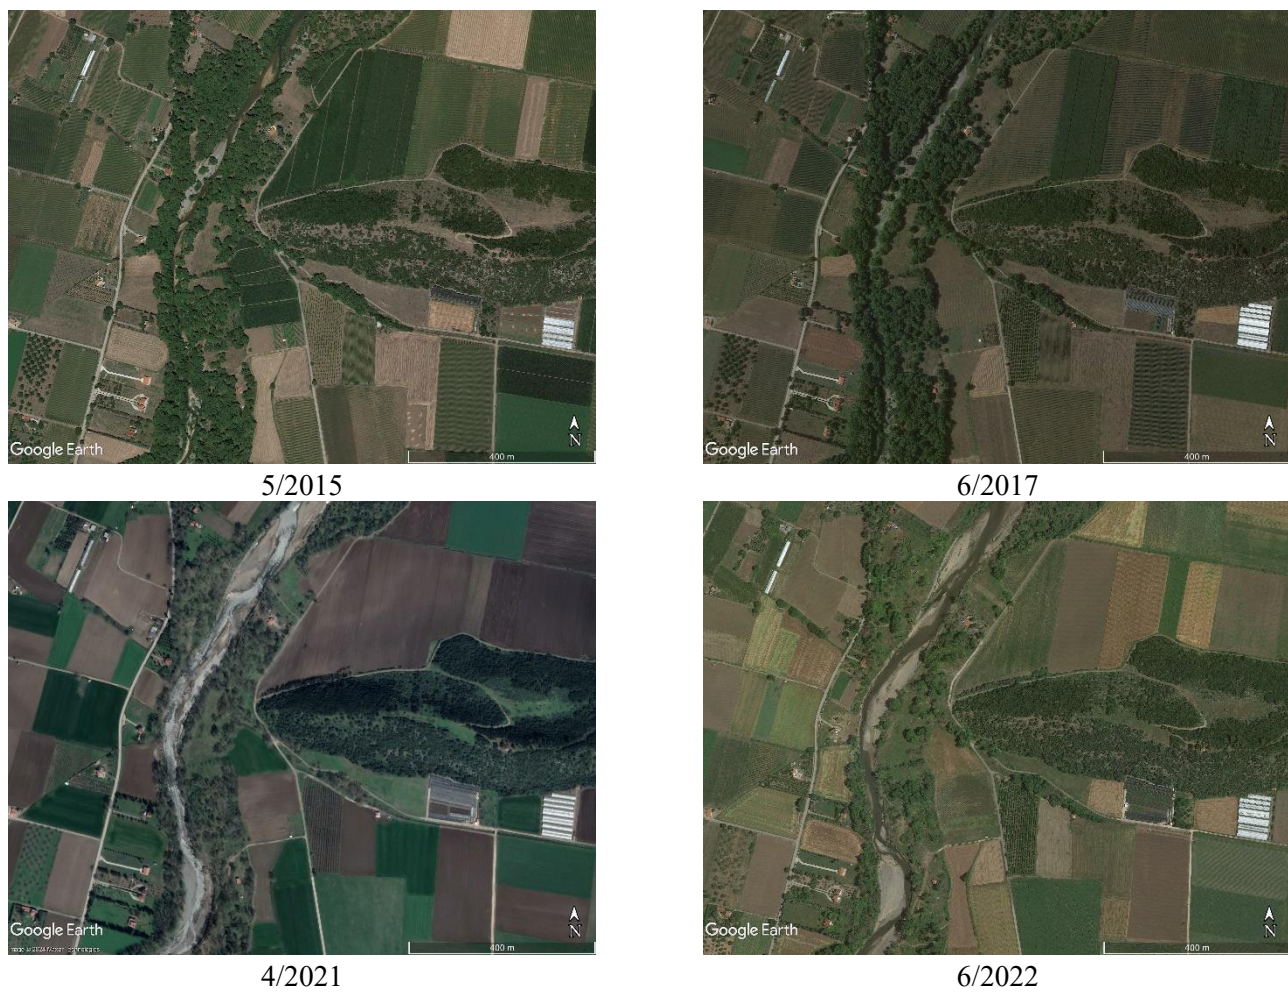
Figure 4. The evolution of the disease in plane trees.

The evolution of the disease in plane trees is depicted in Figures 4 and 5 and more analytically in sections 1 and 2 of the supplementary material in which is presented a detailed study on the evolution of flora in the riverbed of the

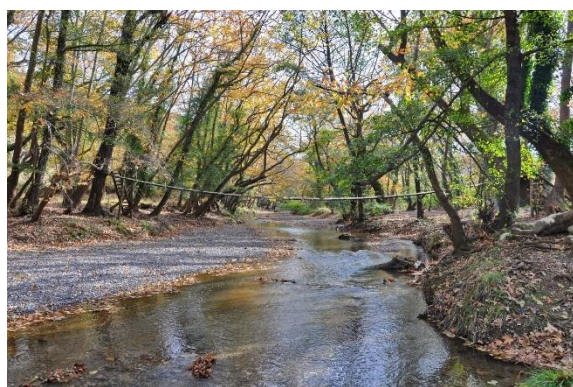
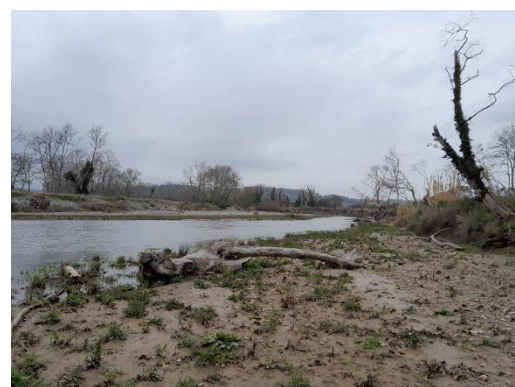
Figure 5. The riverbed in the mouth of the Voudouros river **(a)** before mid-2010s and **(b)** in 2022.

Voudouros River, including comparative analyses of the riverbeds before the mid-2010s and in 2022 for the Voudouros, Nileas, and Kireas rivers.

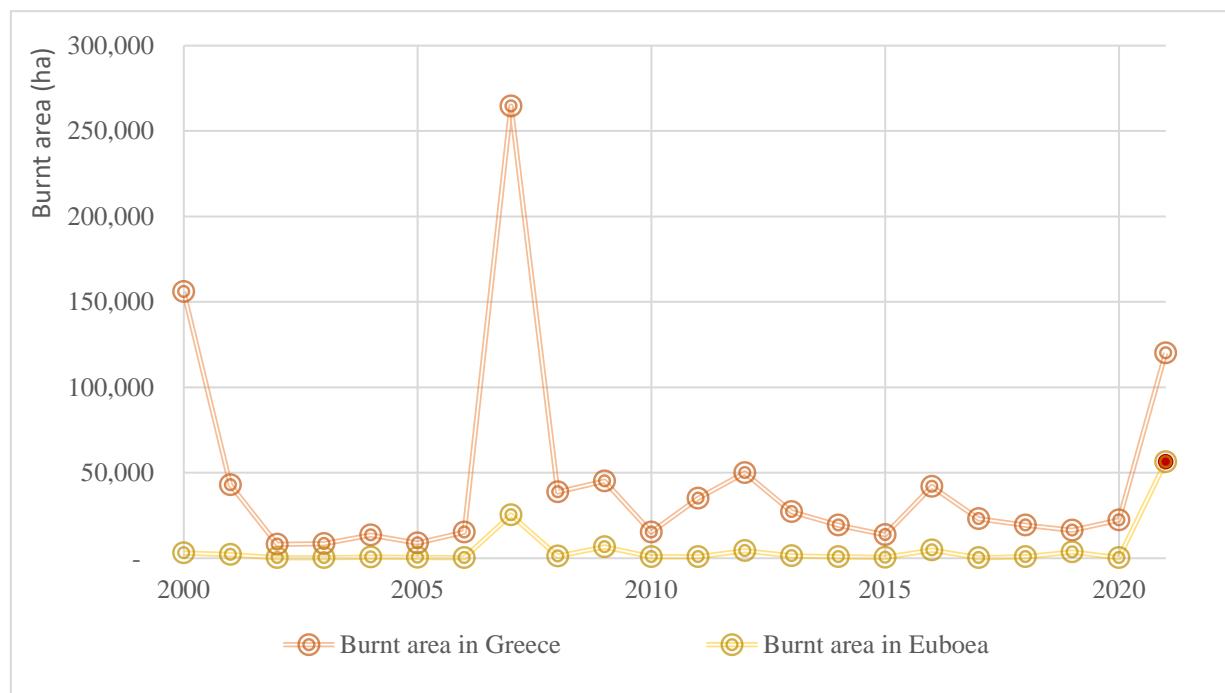
Figure 6. The evolution of wildfires in Greece and Euboea (2000–2021) [7,16].

huge clusters [14] to easily act as abundant fuel material with the potential to produce megafires. This is verified by the fact that megafires in Euboea have recorded in 1977, 2007 and in 2021 [15] (Figure 6).

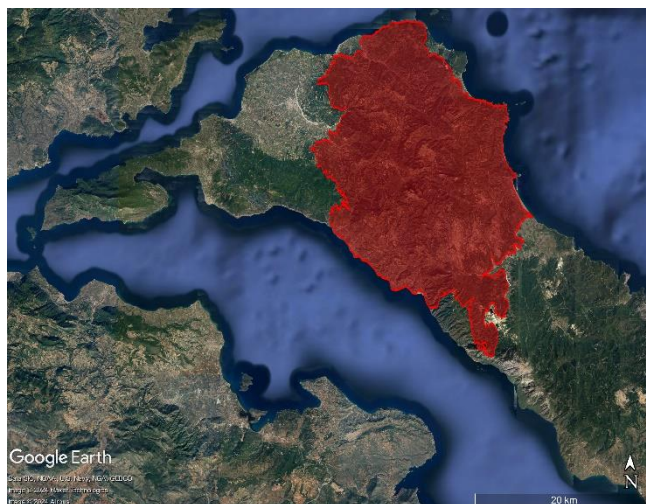
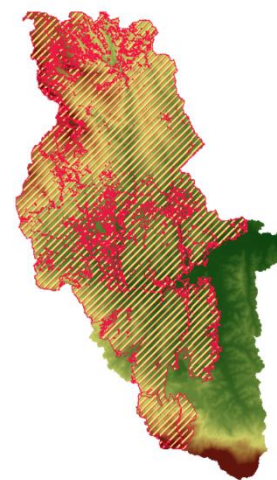
Figure 7. (a) The area of wildfire in 2021 (source [10,16] after adaptation); (b) The burned area in river basin of Nileas River [17].

The effects of the 2021 wildfire, which occurred in North Euboea (Figure 7a), resulted in the decrease of the interception, increase in runoff, altered soil characteristics and roughness, and increase in stormflow volume and peak flow. In addition, other significant increases were noted, influenced by the fire intensity and watershed features.

In total, an area of 125.48 km² was burned, while in the Nileas' River basin, 68% of the total area was affected by the fire, impacting river flow and flood patterns (Figures 7b and 8).

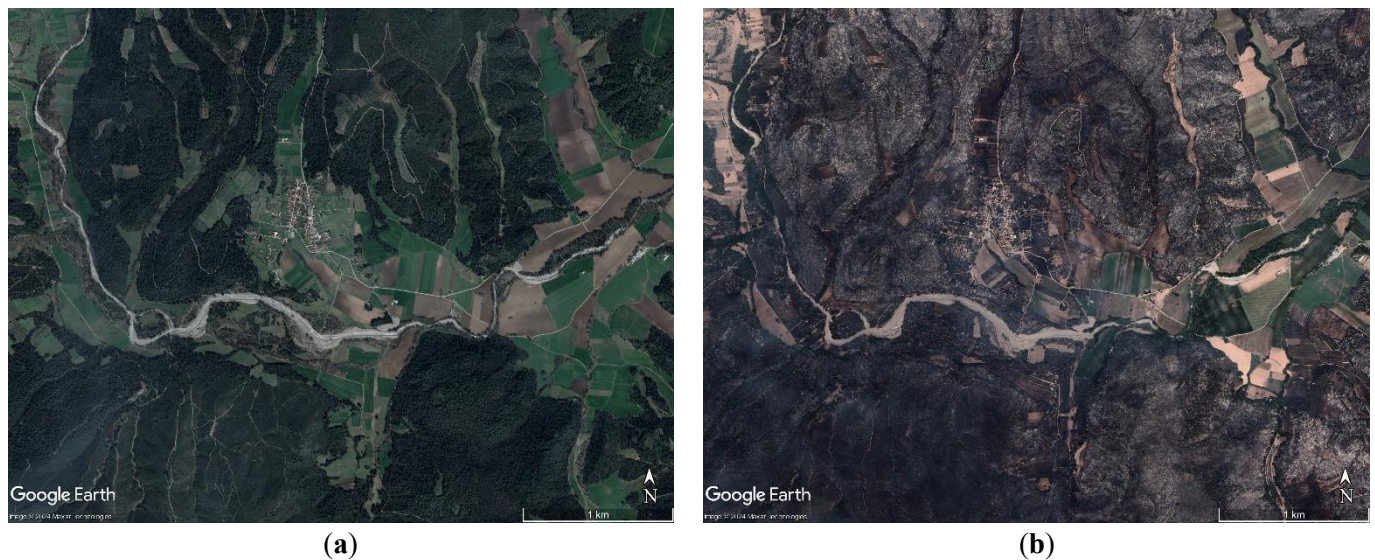
Figure 8. A part of the basin of Nileas River (a) before the wildfire (April 2021), and (b) after the wildfire (August 2021) (source [10] after adaptation; more analytical view in section 3 of the supplementary material).

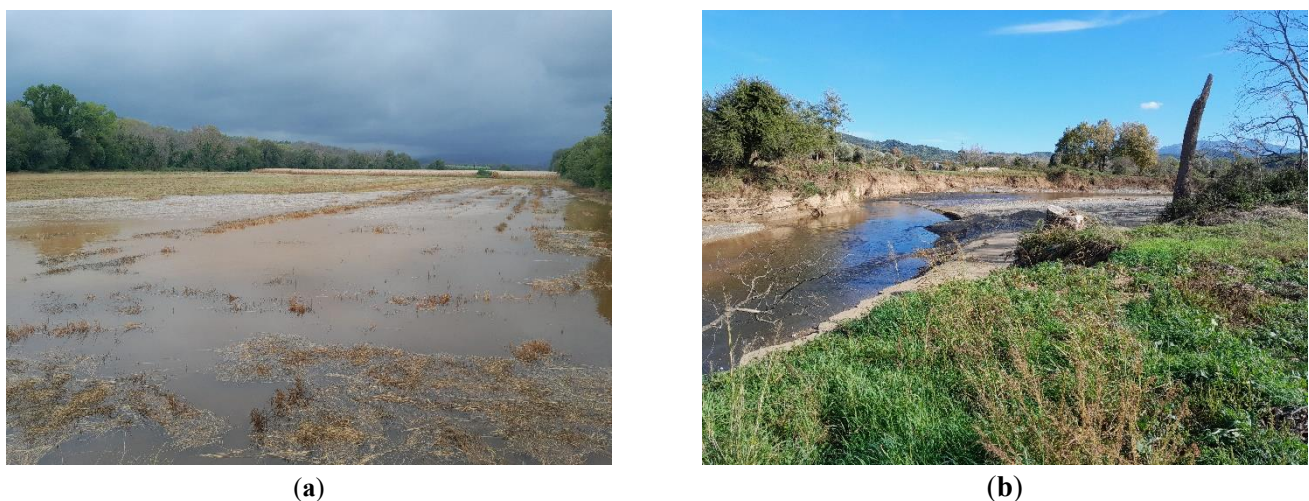
Figure 9. (a) Flood plains in Nileas River basin during storm Daniel (b) Alterations in riverbed after storm Elias.

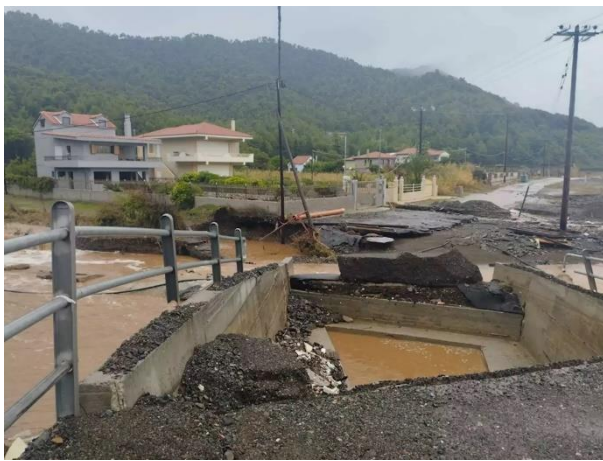
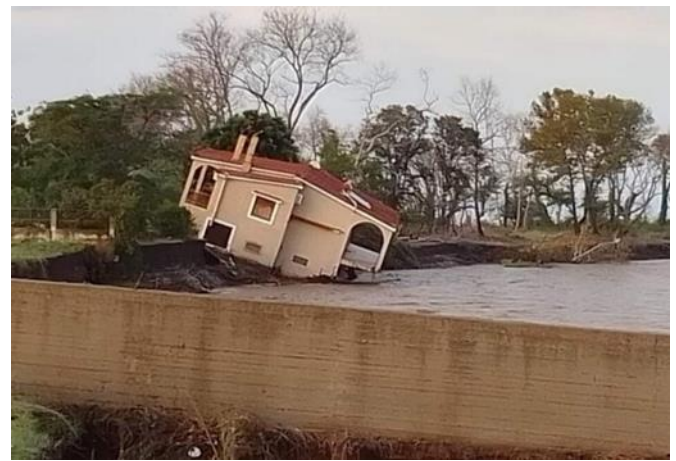
Figure 10. (a) Collapse of infrastructure (source: [24]) (b) Collapse of private properties (source: [25]).

Storms Daniel and Elias occurred in September 2023 [20] and significant rainfall was reported across many Greek regions as also documented by Copernicus [21]. Cities Limni and Istiaia recorded 216 mm of rainfall in 7 h and 140 mm of rainfall in 3.5 h respectively [22,23]. Riverbed widened by Storm Elias, leading to crop destruction (Figure 9) alterations in riverbed (Figure 9b) and the collapse of civil infrastructures and private properties (Figure 10) [20].

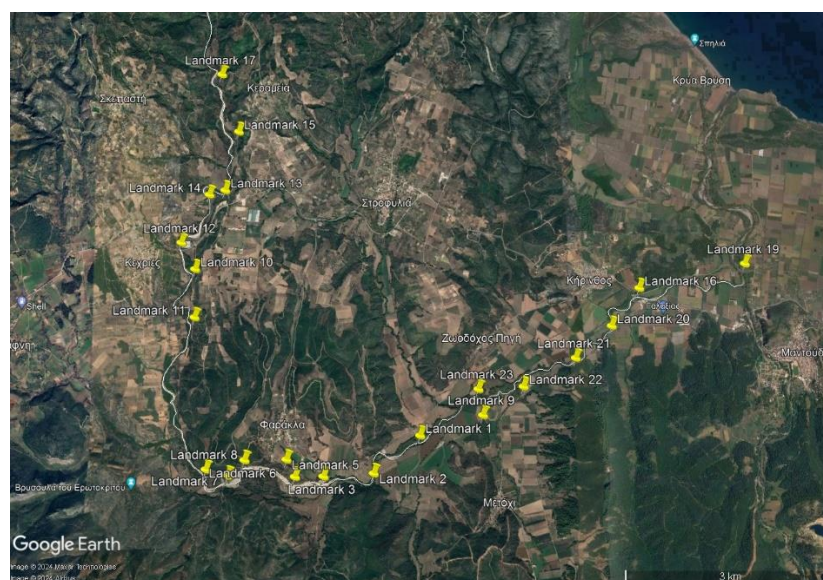
Figure 11. Landmarks for the on-site inspection in Nileas riverbed.

Following the on-site inspection of April and after Daniel/Elias events in September 2023, field research in November 2023 was repeated to review the landscape and observe alterations in the riverbed [27]. The primary objective of this research initiative was to gain a deeper understanding of how the environment had been affected post-flooding and to document any notable changes. The landmarks of on-site inspections were the same as those used during the April on-site field research (Figure 11) as well as a few others along Voudouros (downstream of the confluence of Kireas and Nileas) appears impressive alterations in the configuration of the landscape. An example of the on-site inspection is presented in Figure 12 and more analytical in Section 4 of the Supplementary Material.

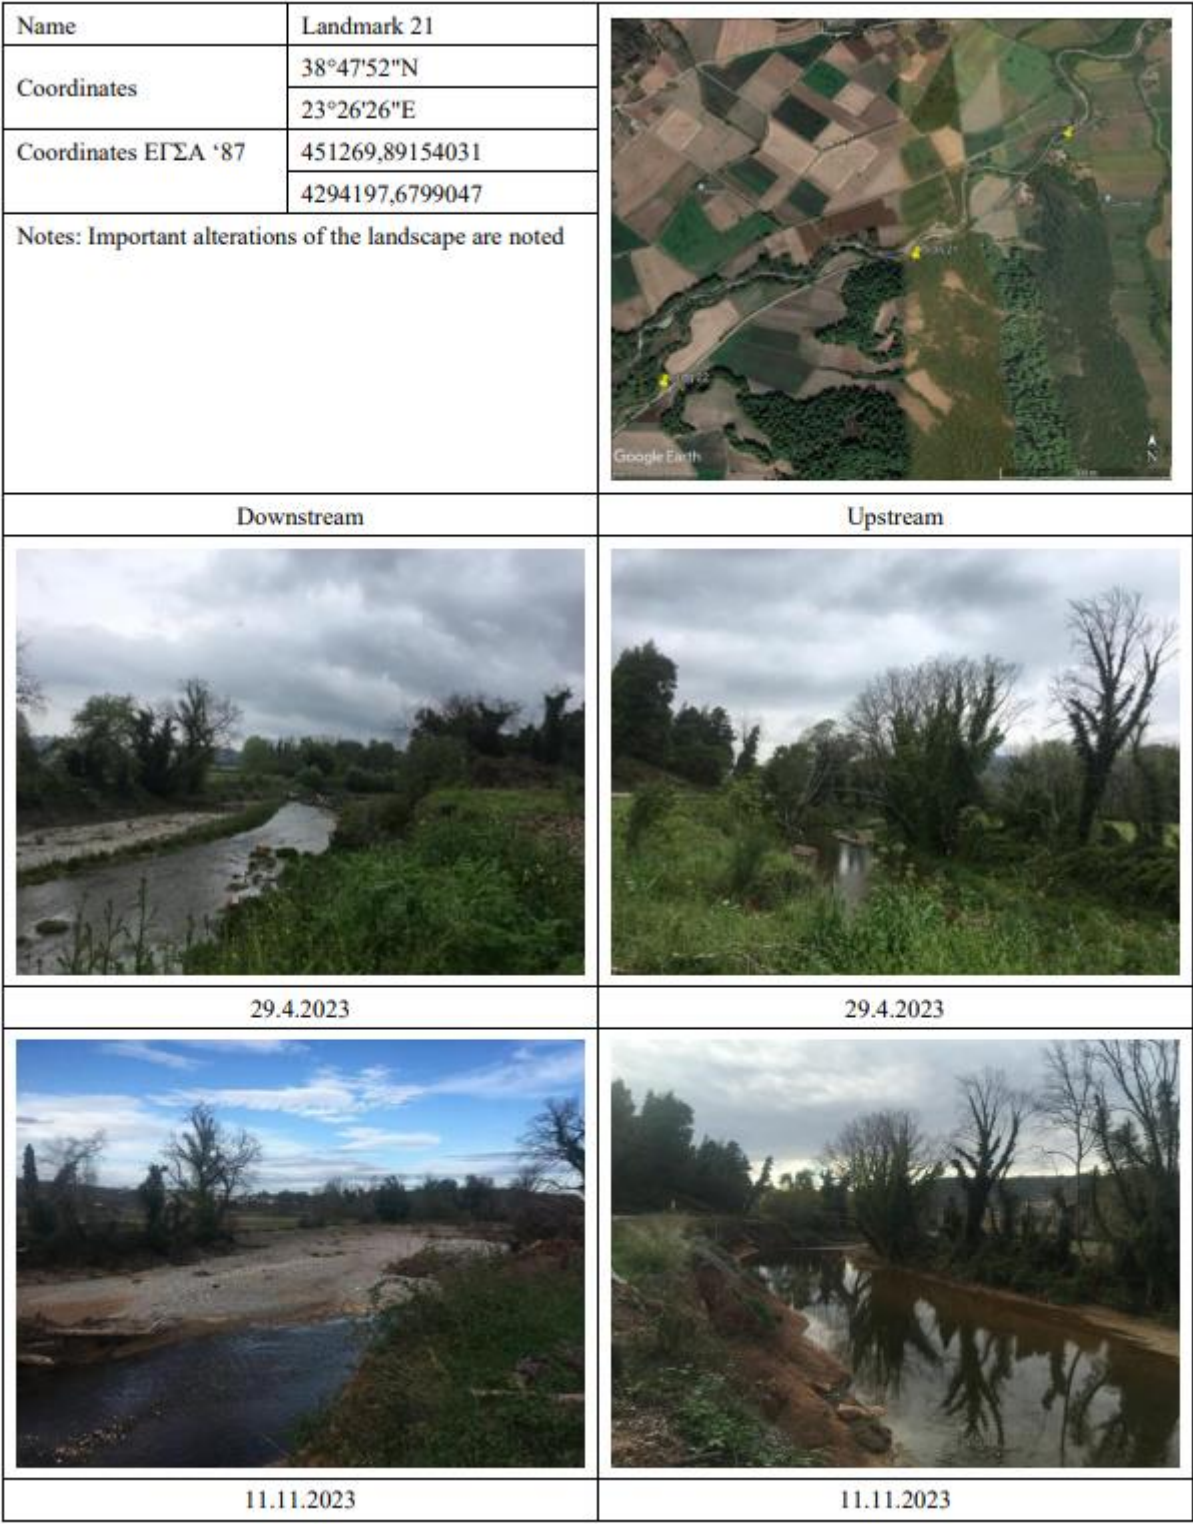
Figure 12. Example of the on-site inspection in Nileas riverbed (more analytical in Section 4 of the Supplementary Material).

- Dramatic alterations in the width of the riverbed after the flood events, especially at lower altitudes.
- Large amount of sediment in the delta of the Voudouros River.
- Change of the natural landscape both along the river and on the beach where the river flows into the sea.
- Destruction of arable land.
- Road collapses in several locations
- Changes in the roughness of the floodplain and the riverbed.
