**EGS – AGU - EUG Joint Assembly,
Nice, France, April 2003**

**Session HS9 - Sediment dynamics and
channel change in rivers and estuaries**

**Channel change and sediment movement
after a major level drawdown at Kremasta
reservoir, Western Greece**

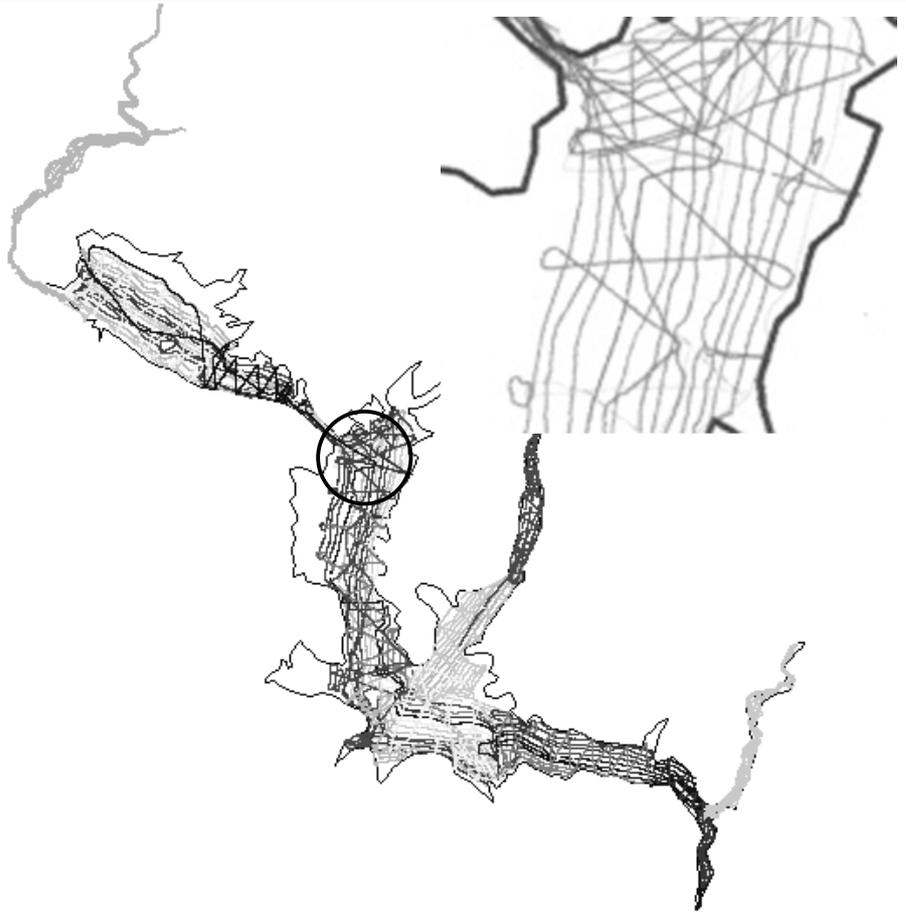
Hydrographic survey of Kremasta reservoir

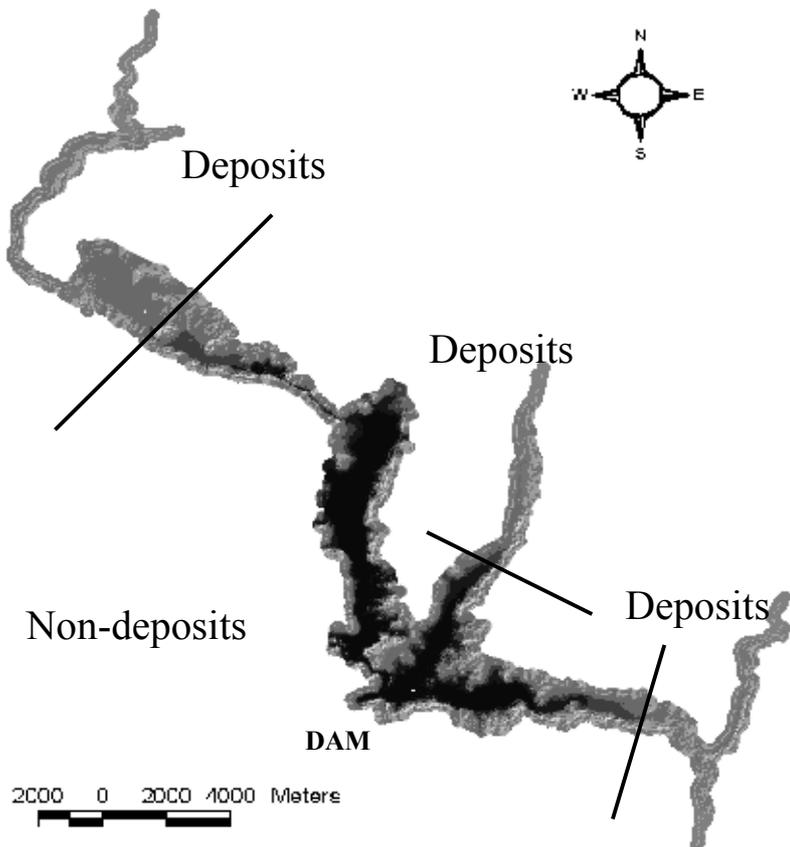
Determination of reservoir segments with sediment deposits

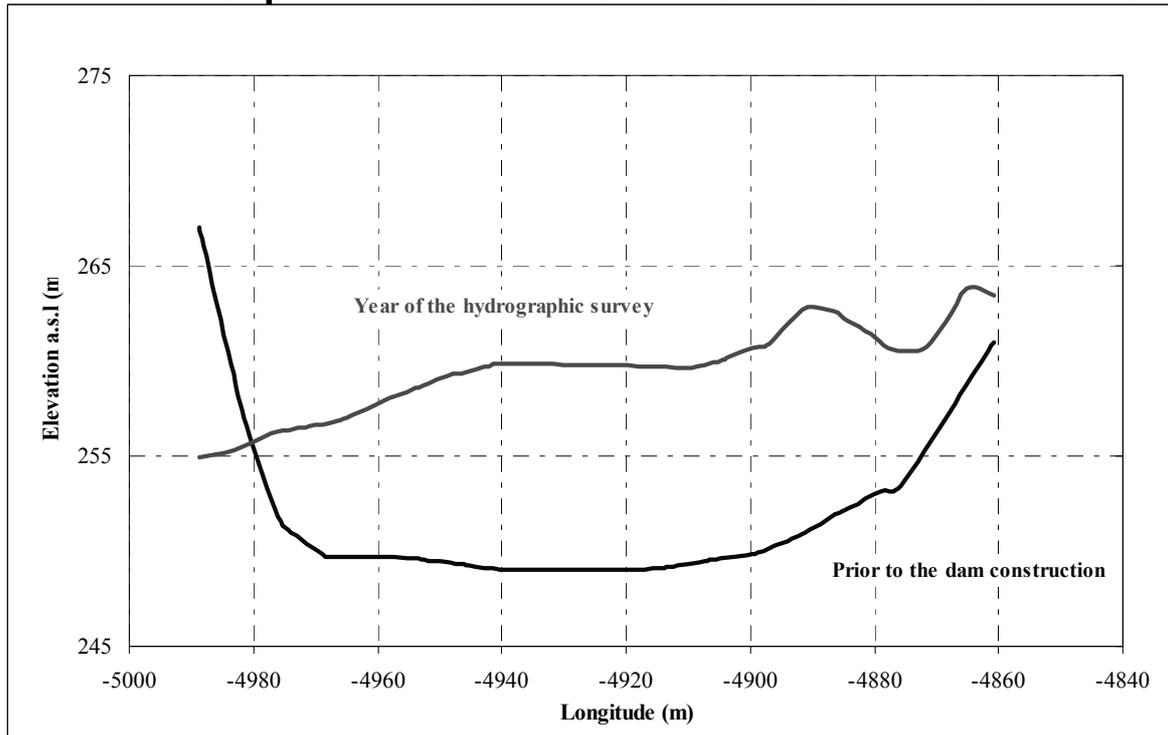
Indicative profile of reservoir sedimentation

Acheloos R. at the reservoir delta

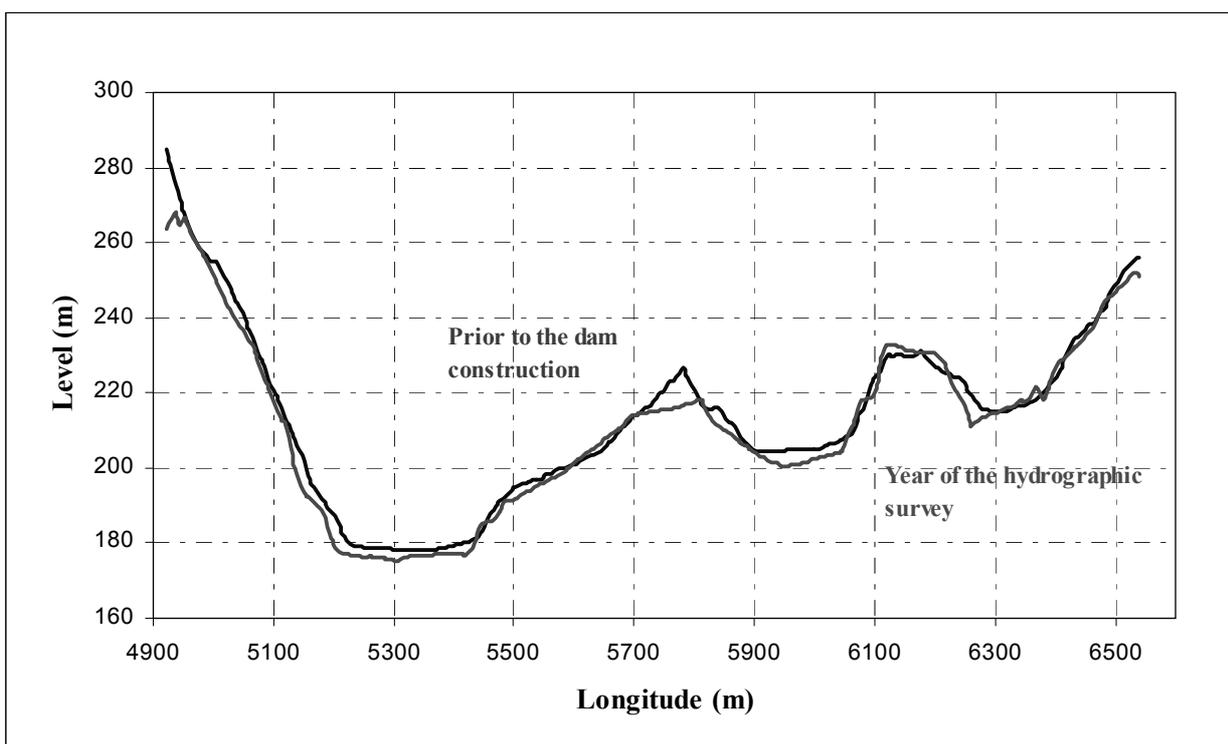
Indicative profile of reservoir sedimentation

Section at the inner part of the reservoir

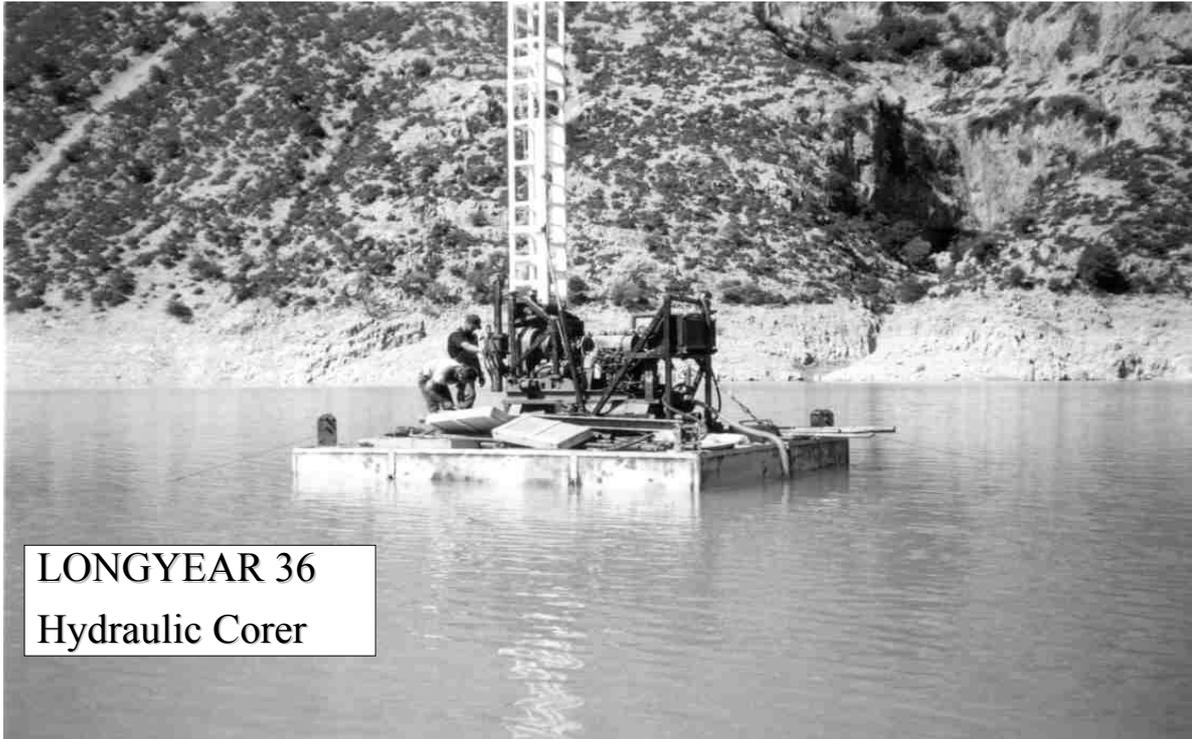
Core samples extraction

LONGYEAR 36
Hydraulic Corer

September 2001

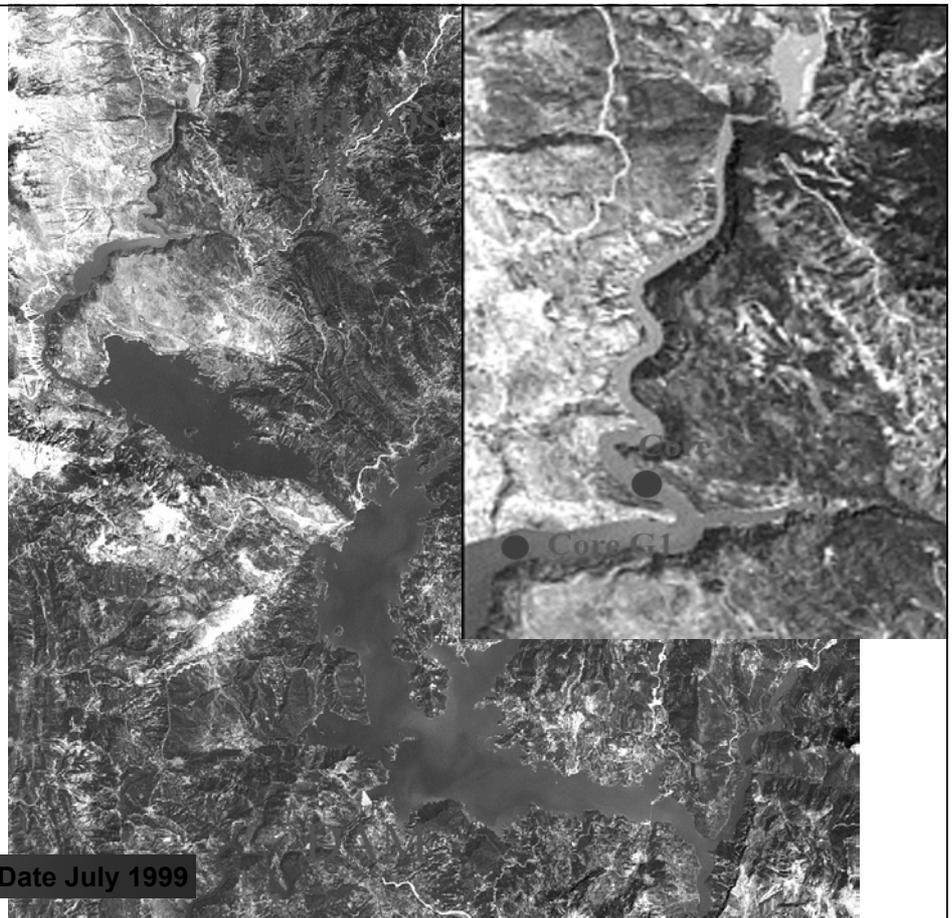
Sites of core samples extraction

LANDSAT ETM+ IMAGE: Date July 1999

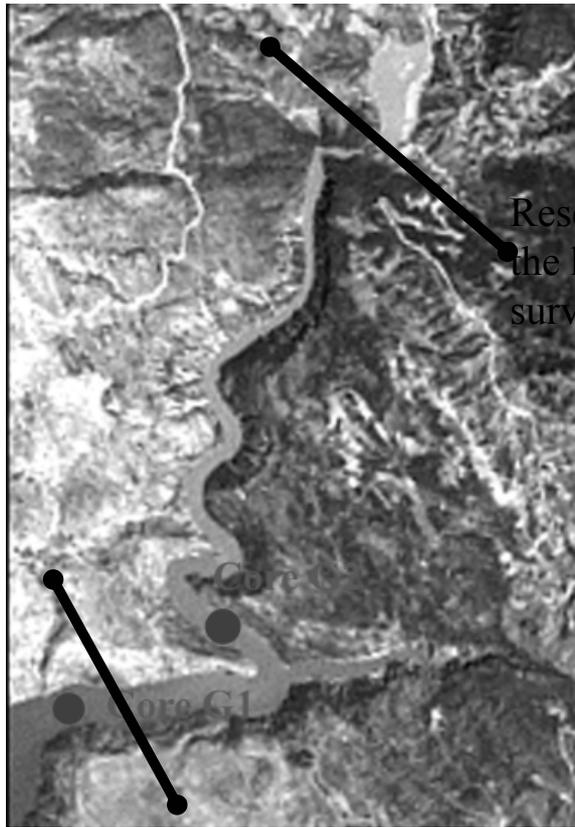
Reservoir level drawdown

Reservoir stage during the hydrographic survey $\approx 269\text{m a.s.l.}$

Reservoir minimum stage between 1998-2001 $\approx 250.8\text{m a.s.l.}$

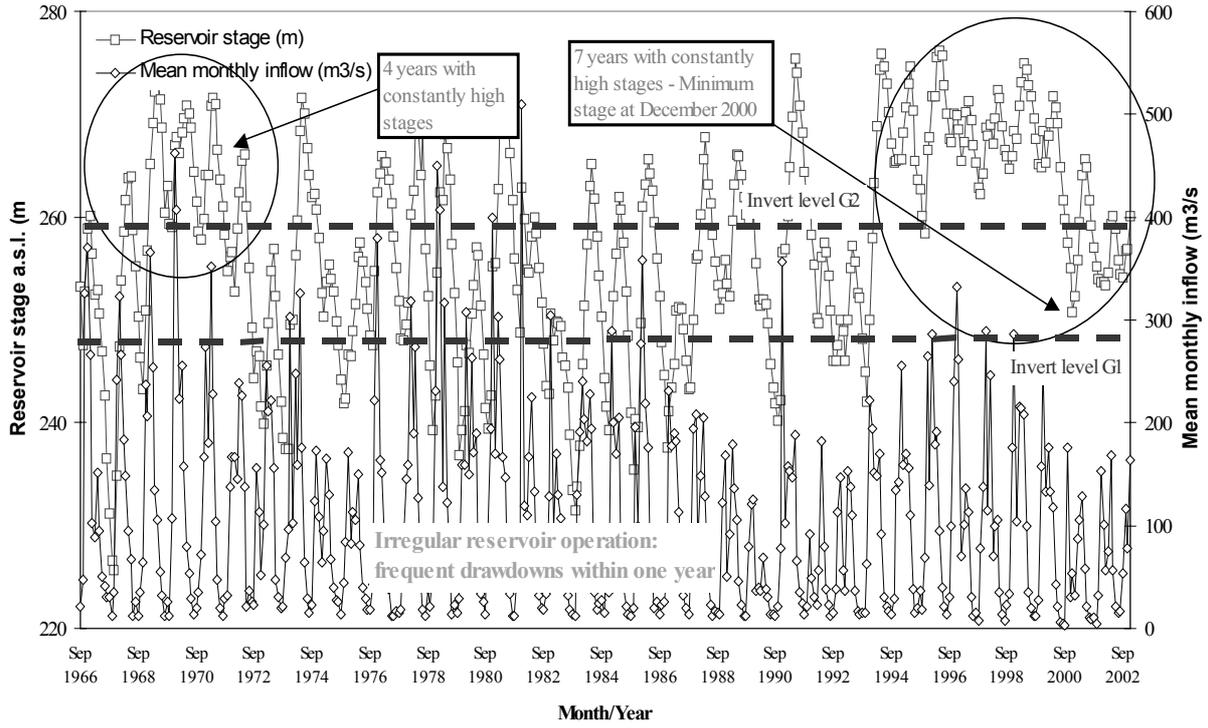
Variation of reservoir stage and water inflow

- **The recent reservoir drawdown is significant but far less from the maximum historical values**
- **The recent drawdown comes after seven consequent years with constantly high reservoir stages**
- **During the period of the last seven years, fine-grained fluvial sediments deposited forming the upper sedimentary layer**
- **Sedimentation continues after the hydrographic survey, as reservoir stages are still high, till the erosion eventually takes place**
- **At the maximum reservoir drawdown, the exposed sediment deposits were easily scoured, even from quite frequent river discharges**
- **It is possible, that a portion of the eroded sediments from core G2 transported downstream till the sedimentary core G1, which exhibits an increase of sediment depth since the hydrographic survey**

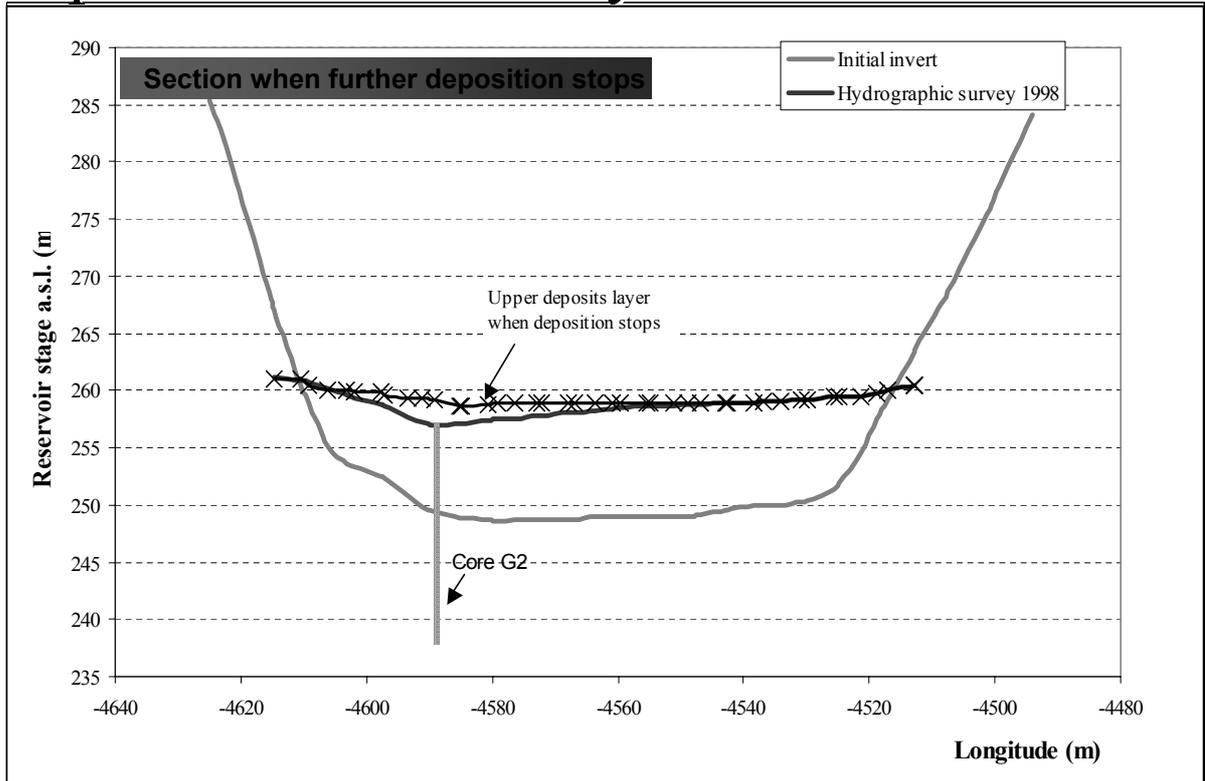
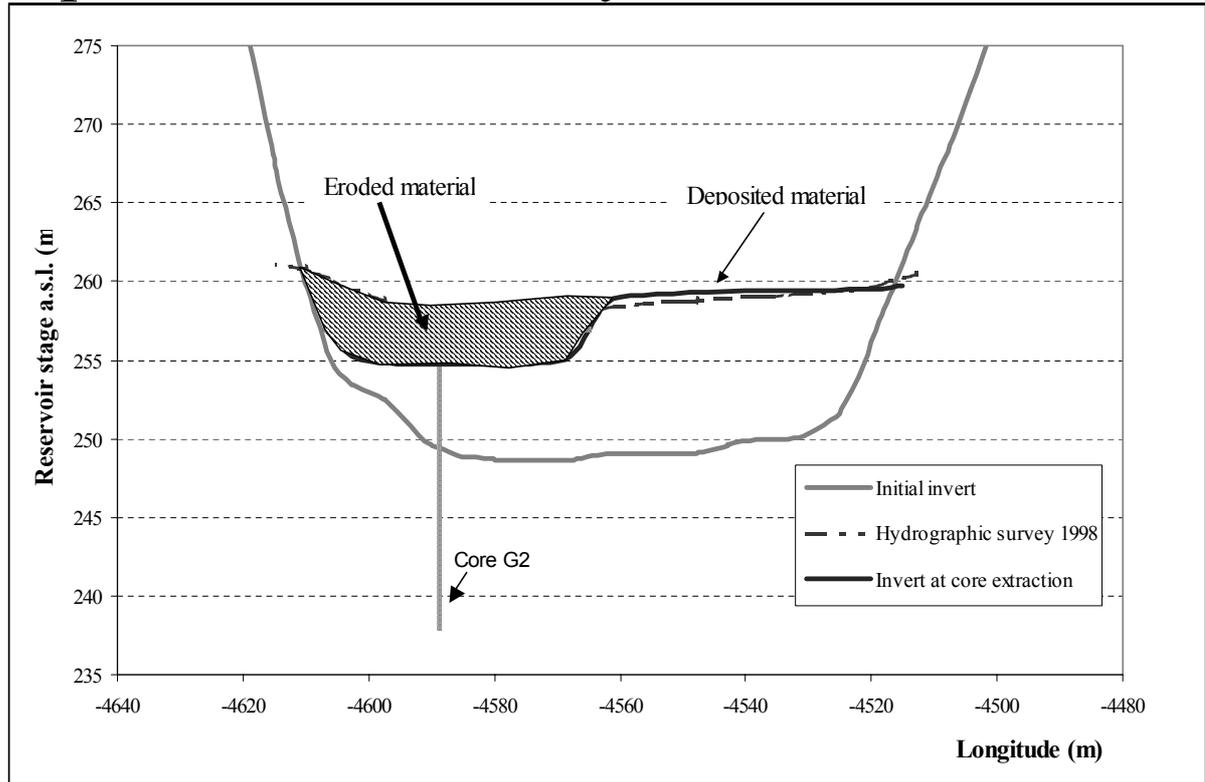
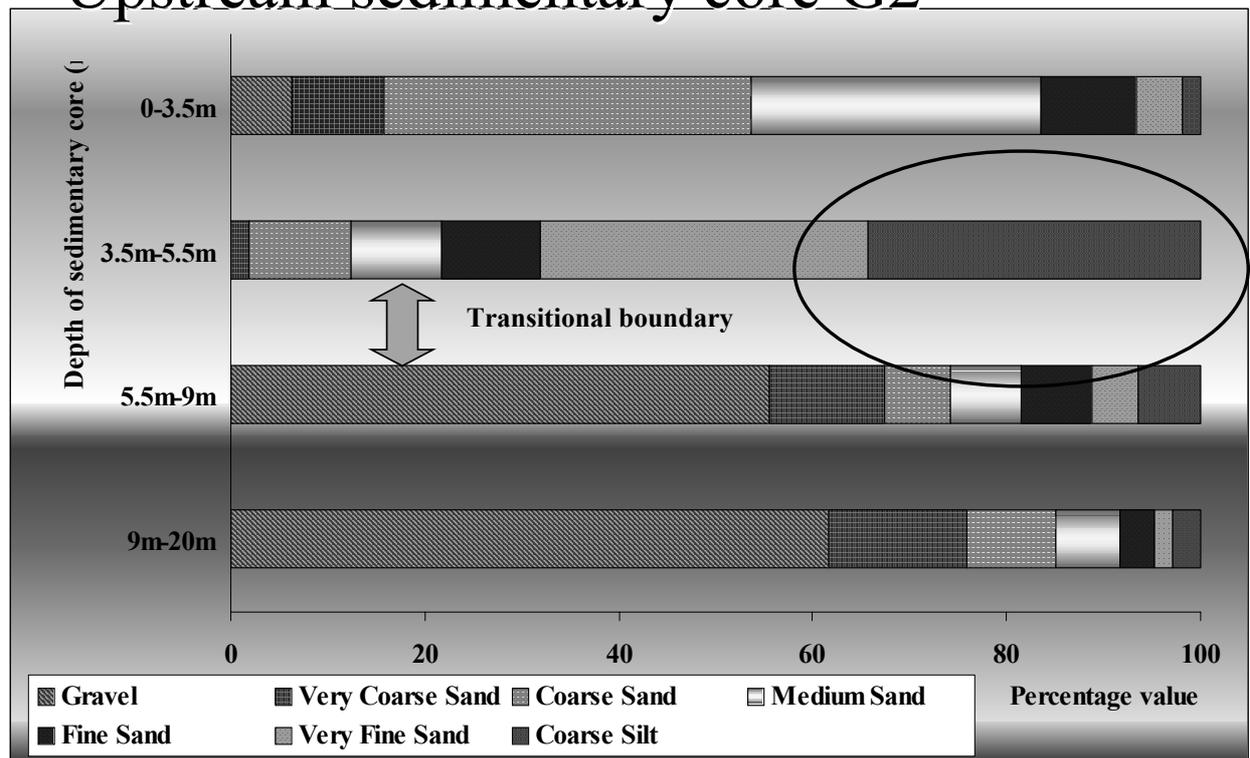
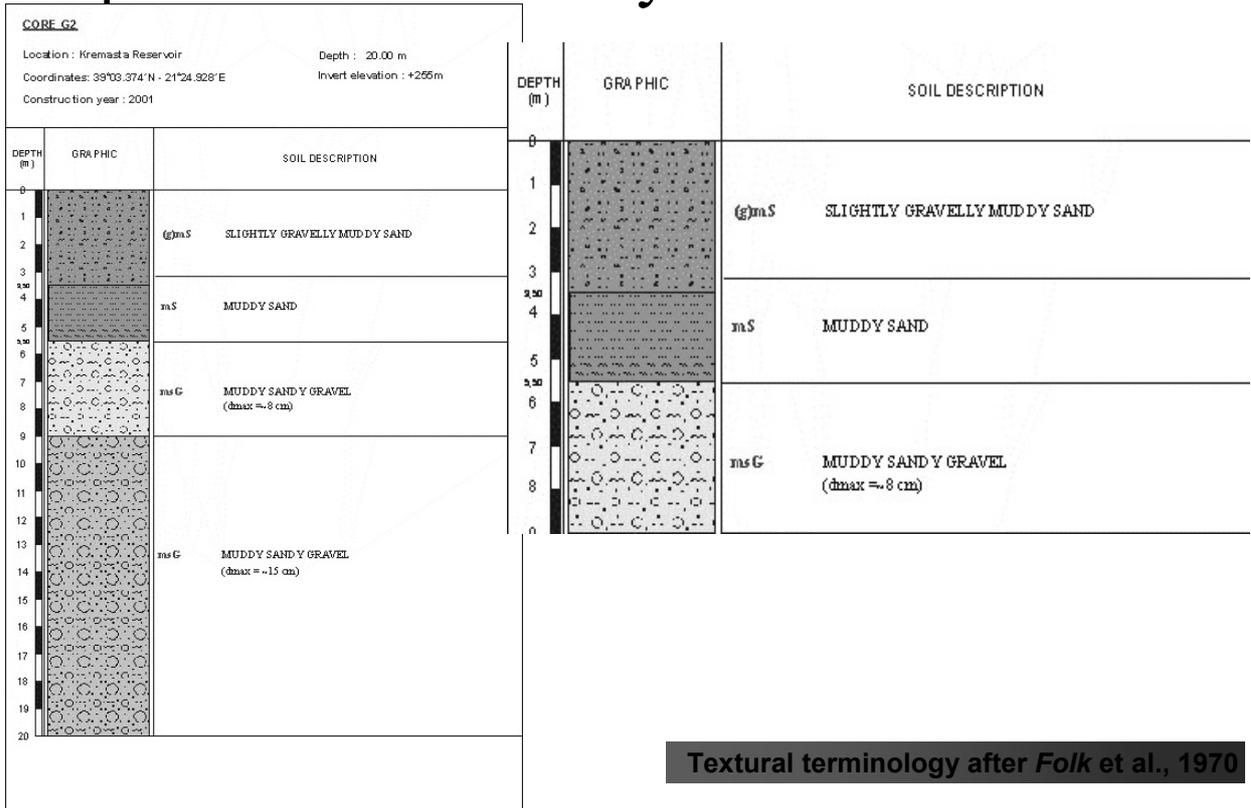
Upstream sedimentary core G2

- **Well-sorted sediment strata reveal undisturbed depositional environment, stable hydraulic conditions or a unique source of sediment (e.g. high reservoir stages)**
- **On the contrary, poorly sorted sediment strata indicate unstable hydraulic conditions, e.g. river flow due to low reservoir stages and intense incoming floods and multiple sediment sources**
- **In both sedimentary cores, lower sediment strata exhibit a well-to-moderate sorting, possibly determining sedimentation rates during the first years of reservoir operation with high reservoir stages**
- **In particular, the prevailing of silt and very fine sands at the lower level of sediments at the core G2, reveal that the first depositional environment of high reservoir stages occurred between 1969 and 1972**

- **Middle sediment strata exhibit poorly - sorted stratification. The extremely frequent stage drawdowns do not support stable depositional environment**
- **The downstream sedimentary core exhibit less uniform sorting, mainly because of the influence of the tributary Granitsiotis River, which supplies sediment from a nearby watershed, additional to sediment transported from the upstream part of Acheloos River.**

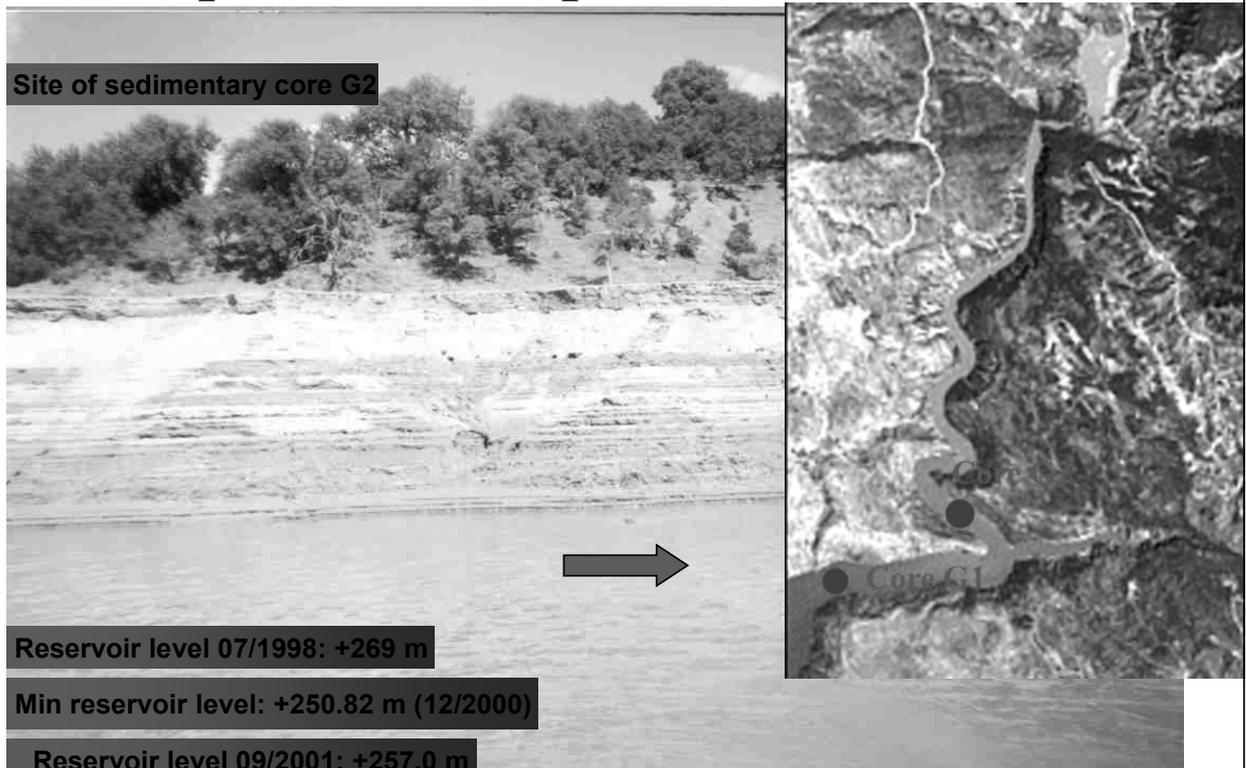
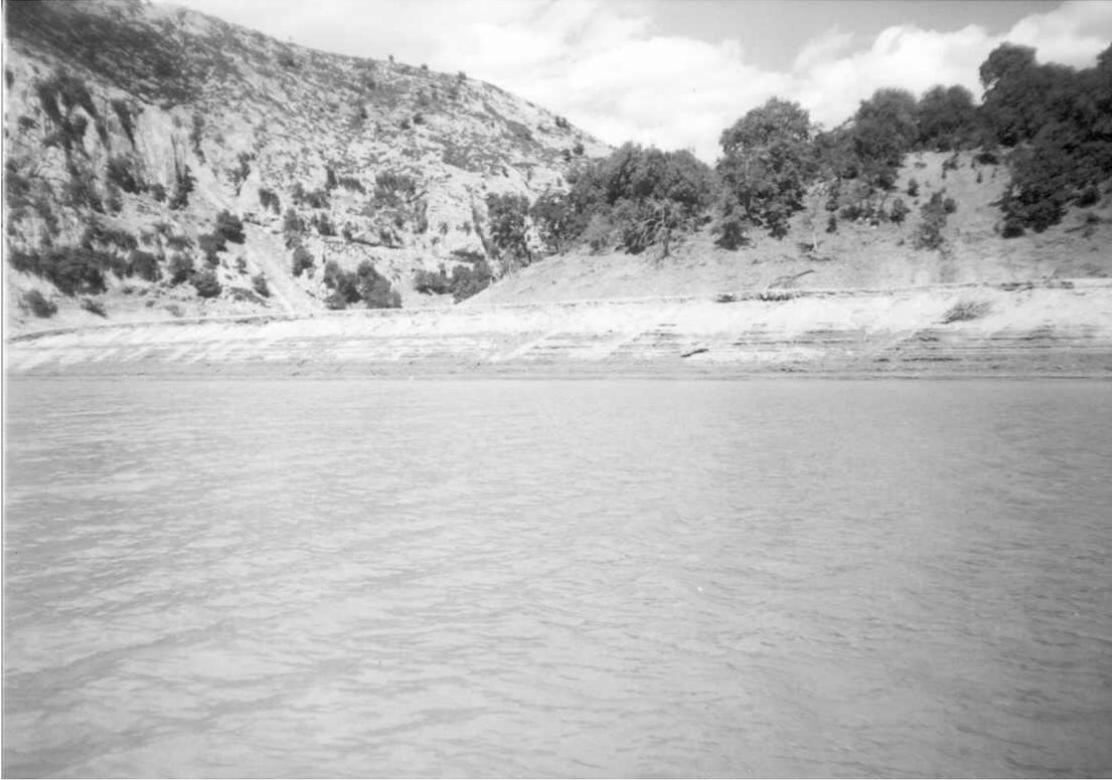
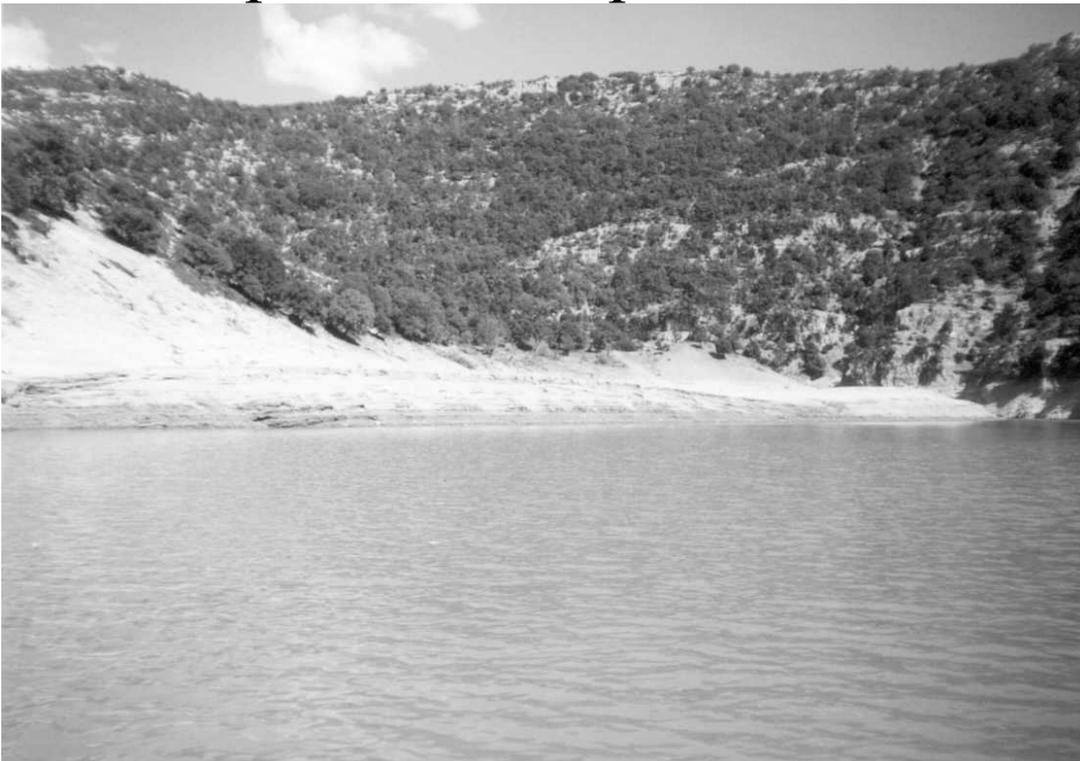
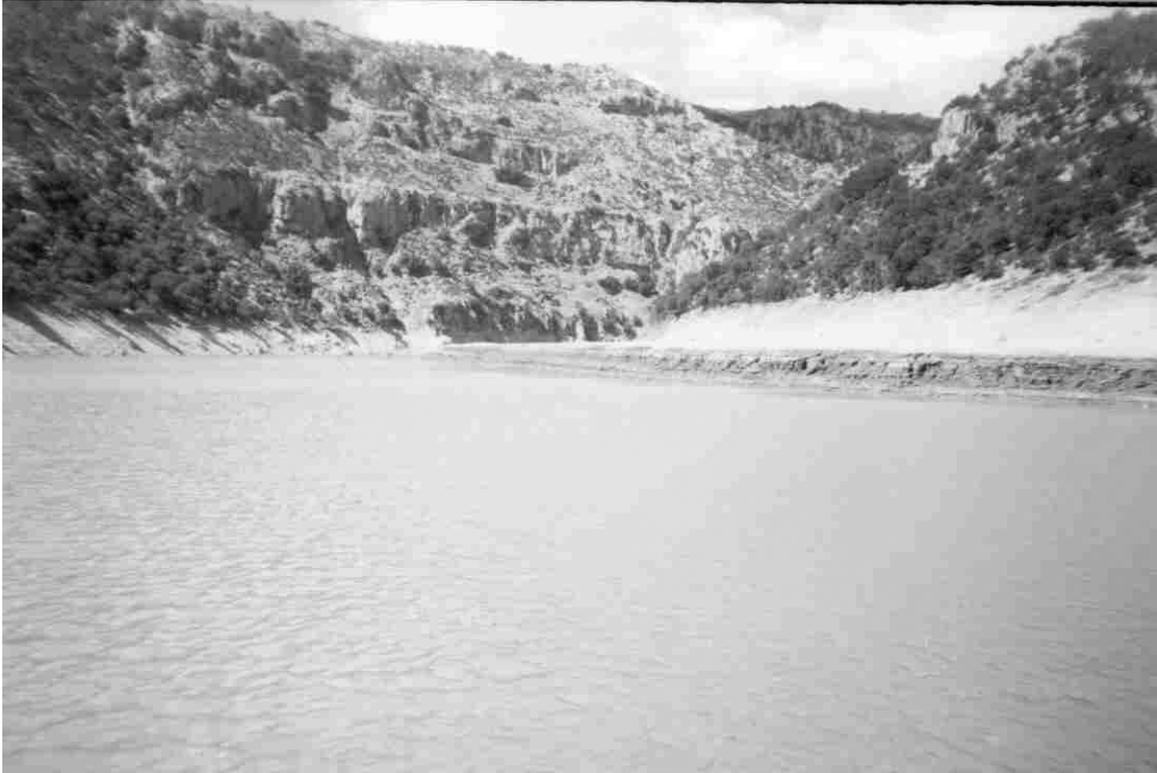
Erosion process of deposited sediments

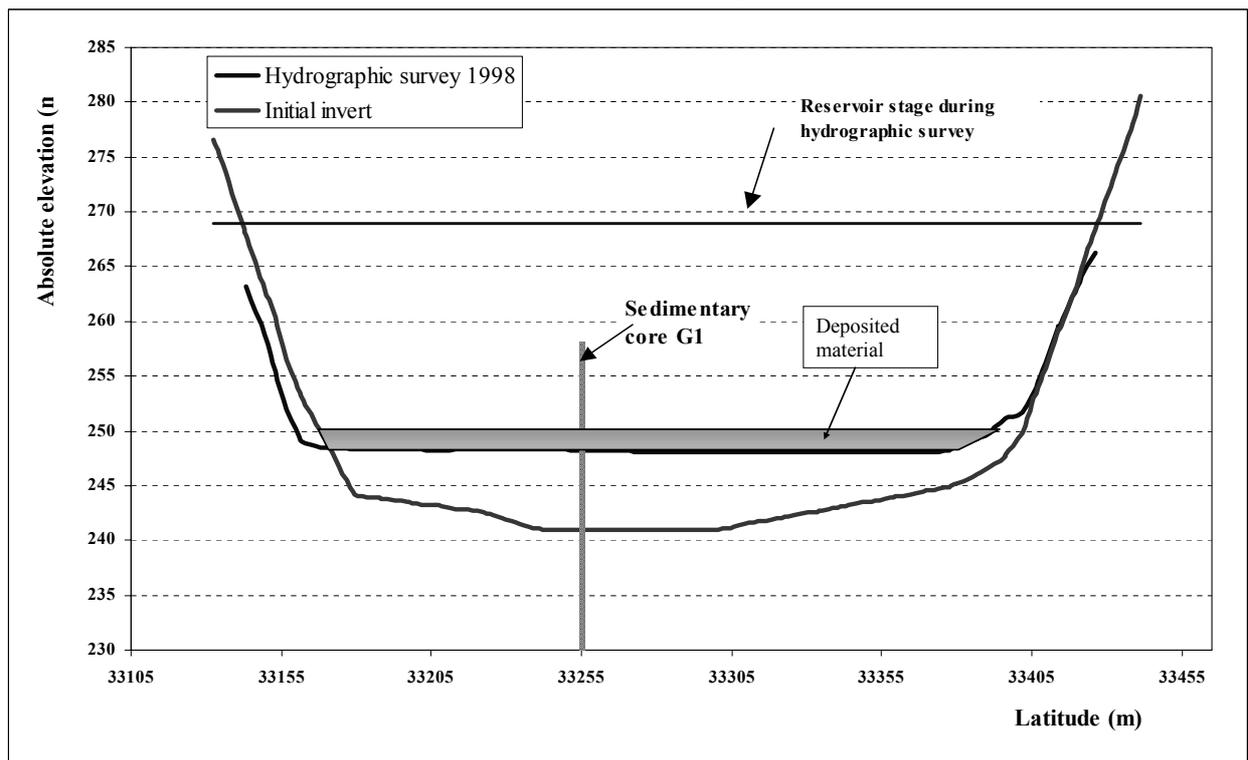
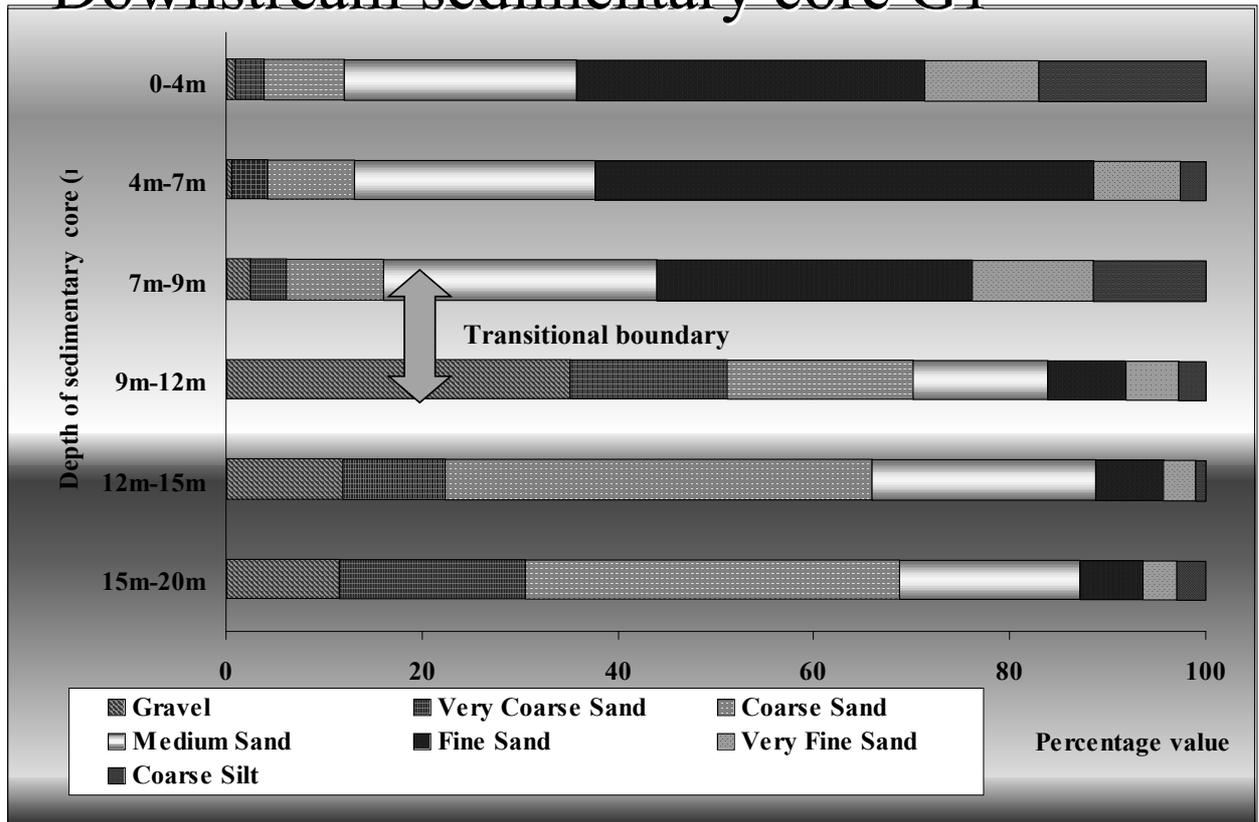
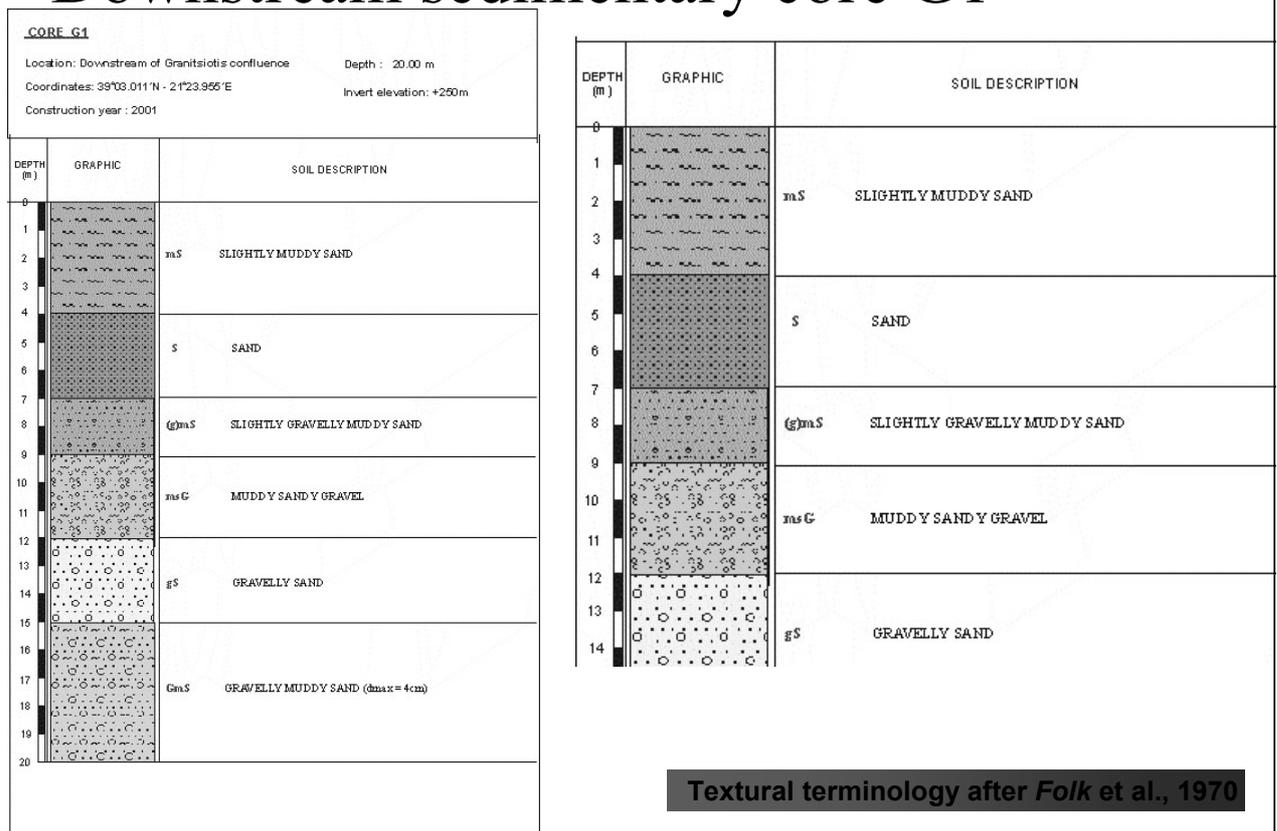
Downstream sedimentary core G1
