NATIONAL TECHNICAL UNIVERSITY OF ATHENS

The Oroville Dam 2017 Spillway Incident

Possible Causes and Solutions

Diploma Thesis

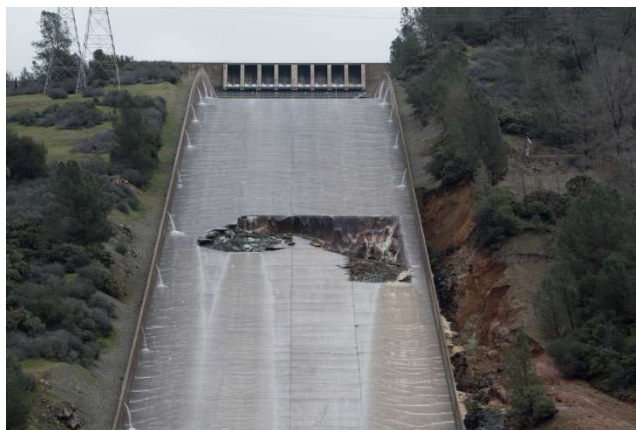
Στις 6 Φεβρουαρίου, εργάτες στο φράγμα Oroville παρατήρησαν μια μεγάλη τρύπα στον πυθμένα του αγωγού του κύριου υπερχειλιστή.

Εικόνα 3. Φεβρουάριος 6, 2017. Πρώτες ζημιές στον αγωγό του κύριου υπερχειλιστή.

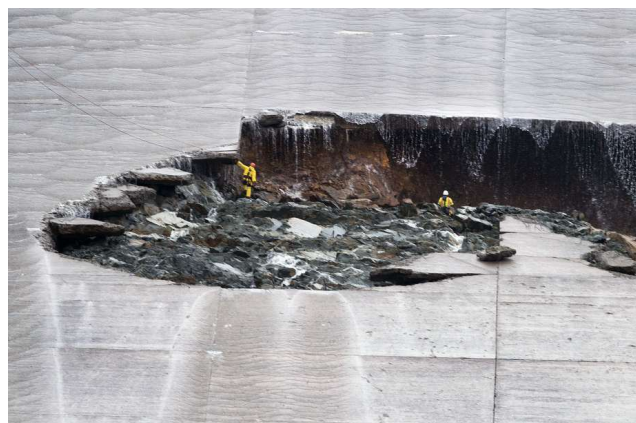
Εικόνα 4. Φεβρουάριος 6, 2017. Εργάτες εξετάζουν από κοντά το εύρος της ζημιάς.

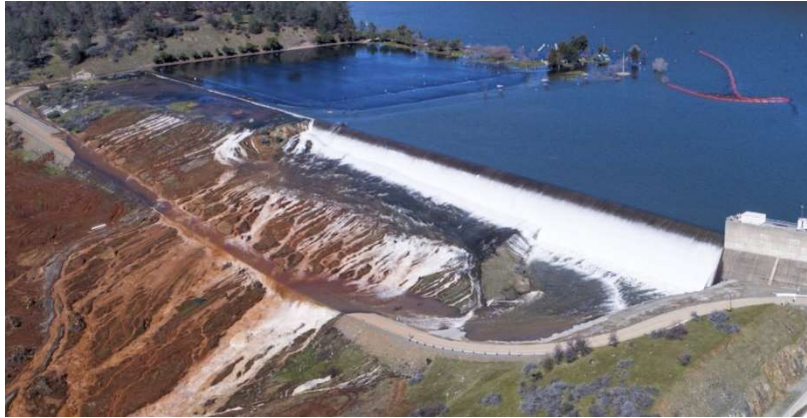
Για να αποφευχθούν περαιτέρω ζημιές στον κύριο υπερχειλιστή, αποφασίσθηκε να μπει σε λειτουργία ο εναλλακτικός. Ωστόσο, γρήγορα χρειάστηκε να διακοπεί η λειτουργία αυτή, καθώς οι ροές κατάντη του διάβρωσαν γρήγορα το έδαφος από κάτω, κινδυνεύοντας να φτάσουν κάτω από τον υπερχειλιστή έκτακτης ανάγκης και να τον καταστρέψουν. Τότε, κρίθηκε απαραίτητη η χρήση του τρυπημένου κύριου υπερχειλιστή, ο οποίος μπόρεσε να αντέξει μεγάλες εκροές χωρίς να καταστραφεί ολοσχερώς.

Εικόνα 5. Φεβρουάριος 11, 2017. Ο υπερχειλιστής έκτακτης ανάγκης μπαίνει σε λειτουργία.

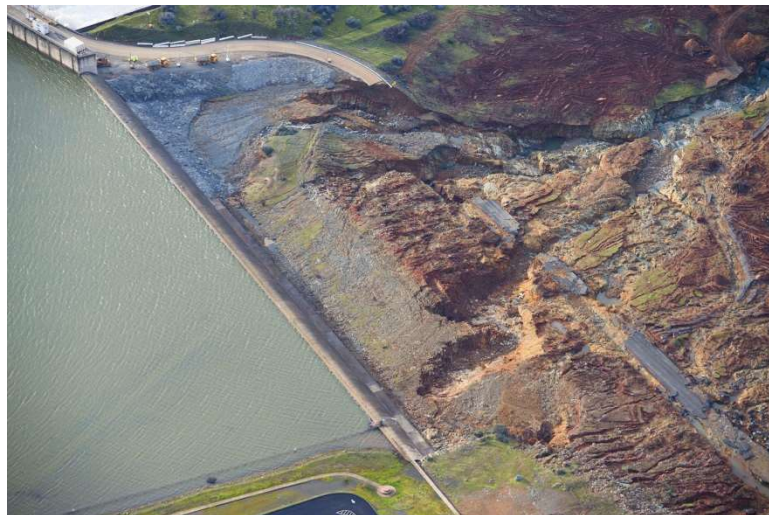
Εικόνα 6. Φεβρουάριος 13, 2017. Ζημιές στον εναλλακτικό υπερχειλιστή του φράγματος Oroville.

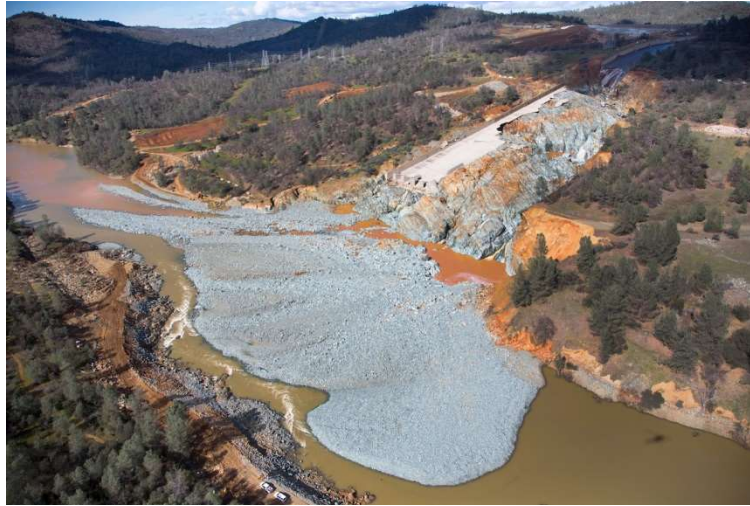
Εικόνα 7. Φεβρουάριος 27, 2017. Ζημιές στον κύριο υπερχειλιστή του φράγματος Oroville.

Μετά το ατύχημα, η τοπική υπεύθυνη αρχή (California Department of Water Resources) αμέσως ξεκίνησε επισκευές στον κύριο υπερχειλιστή και πρότεινε επανζέταση της κατασκευής του εναλλακτικού. Εκτιμάται ότι μέχρι το 2018 οι επισκευές θα έχουν ολοκληρωθεί, ενώ ο κύριος υπερχειλιστής θα είναι ξανά έτοιμος για χρήση.

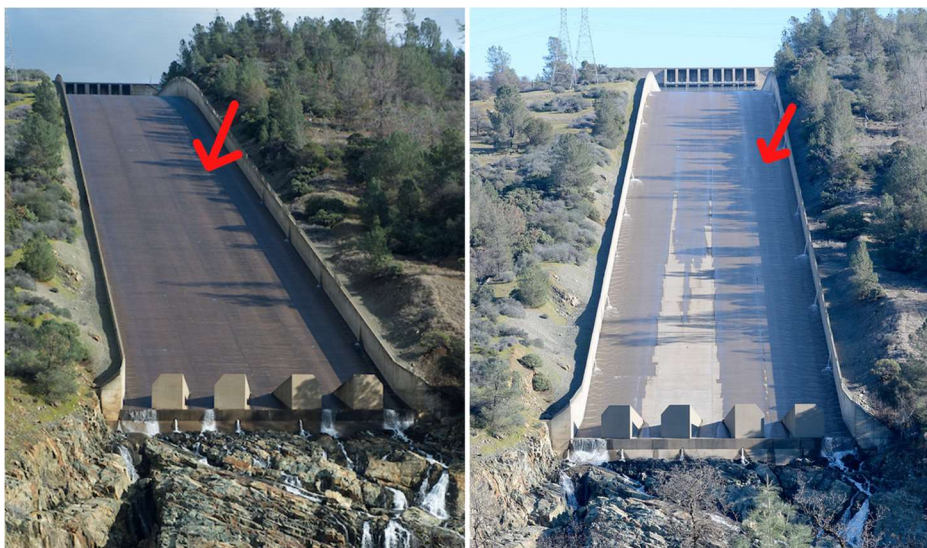
Πρώτον, η αρχική τρύπα στον αγωγό του κύριου υπερχειλιστή προξενήθηκε από μάζα νερού από κάτω του, η οποία είχε περάσει μέσα από κενά στο αποσαθρωμένο πέτρωμα της θεμελίωσης και ανασήκωσε τις σκυροδετημένες πλάκες του πυθμένα. Αυτό επιβεβαιώθηκε μετά από εκτενή μελέτη της βιβλιογραφίας, την κατασκευή μοντέλου του αγωγού και την ανάλυση φωτογραφιών λίγο πριν του συμβάντος.

Εικόνα 8. Φωτογραφίες του αγωγού του κύριου υπερχειλιστή του φράγματος Oroville. Η αριστερή λήφθηκε 11 Ιανουαρίου και η δεξιά 27 Ιανουαρίου. Δεξιά φαίνονται οι πρώτες ενδείξεις της ανασήκωσης των πλακών του πυθμένα.

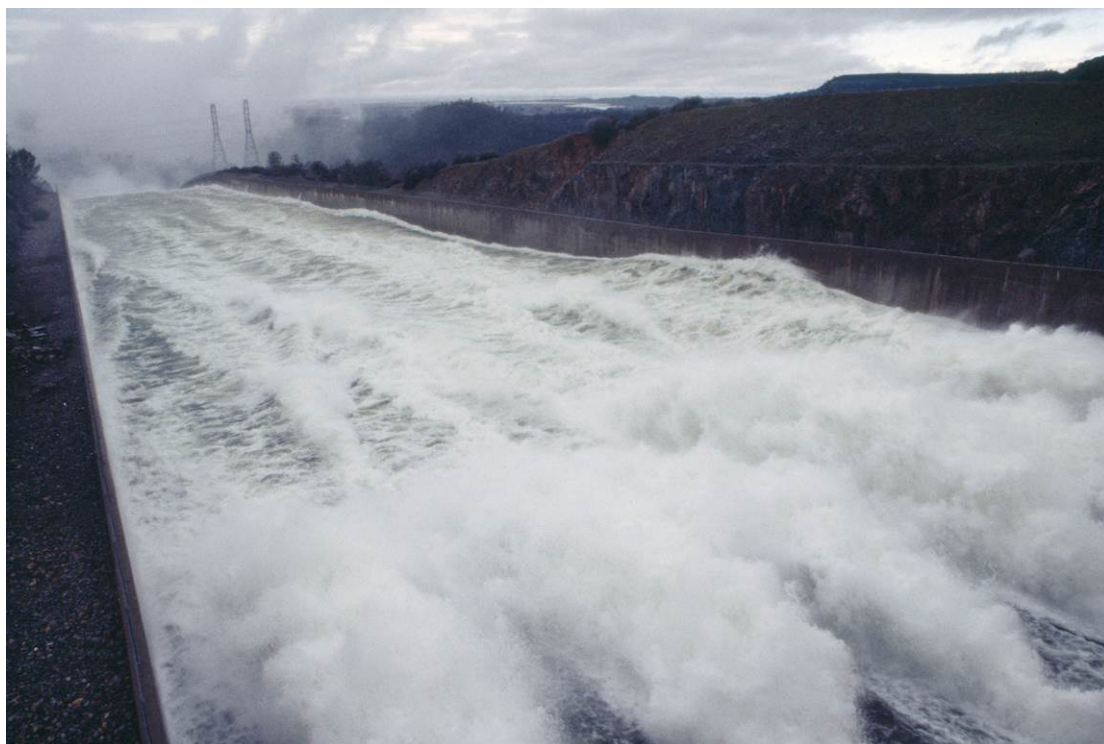
Image 10. January 2, 1997. Side view of Oroville Dam's flood control outlet, as releases reach 4,531 m³/s (160,000 cfs) for the first time in history. Sources: Norm Hughes, DWR.

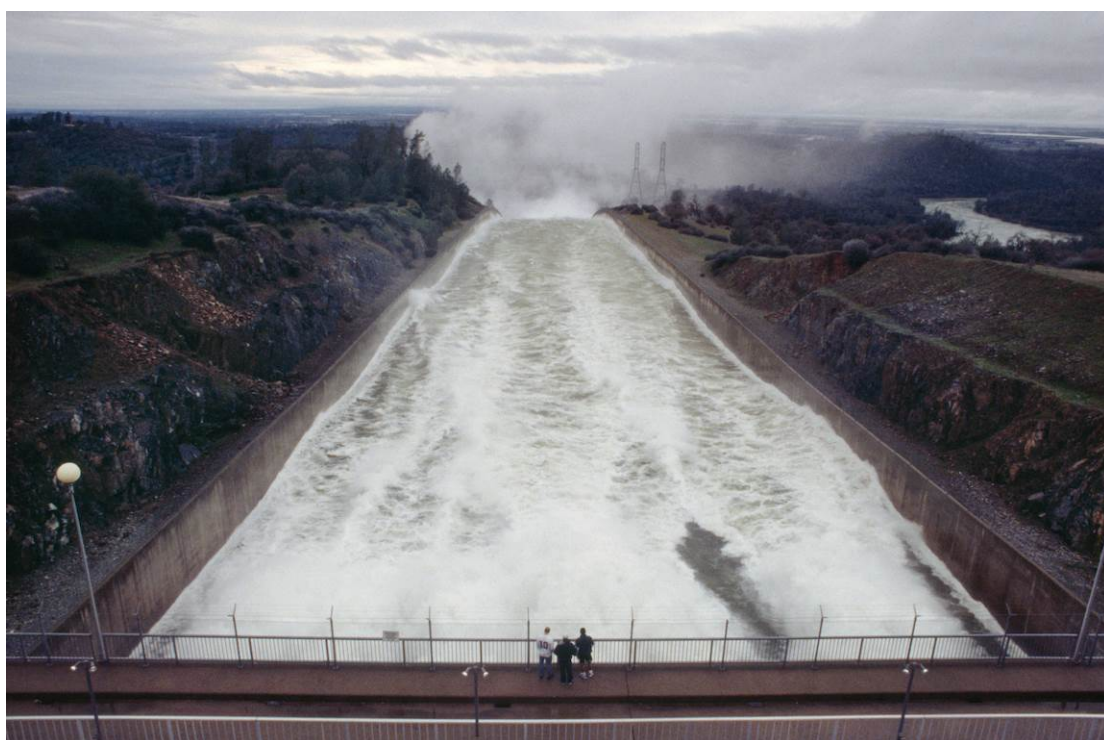
Image 11. January 2, 1997. Top view of Oroville Dam's main spillway. Discharge is 4,531 m³/s (160,000 cfs). Sources: Norm Hughes, DWR.

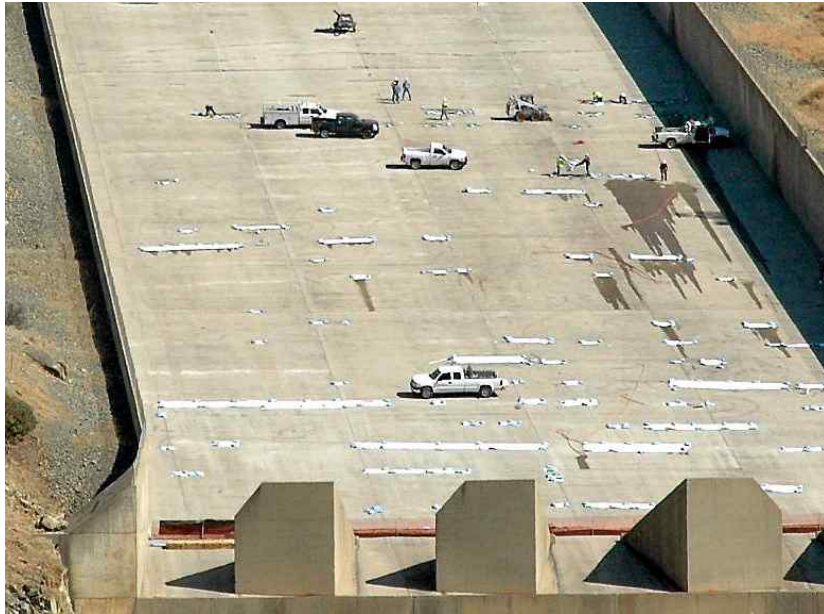
The very next FERC report (Federal Energy Regulatory Commission, 2014) confirms that the DWR has been performing minor repairs to the main spillway chute as recently as 2009. A brief Internet search revealed photos of this chute maintenance. It appears to consist of filling in cracks in the spillway chute with additional concrete.

Image 13. Maintenance of the Oroville Dam main spillway chute. Photo taken in 2009. Source: Barbara Arrigoni.

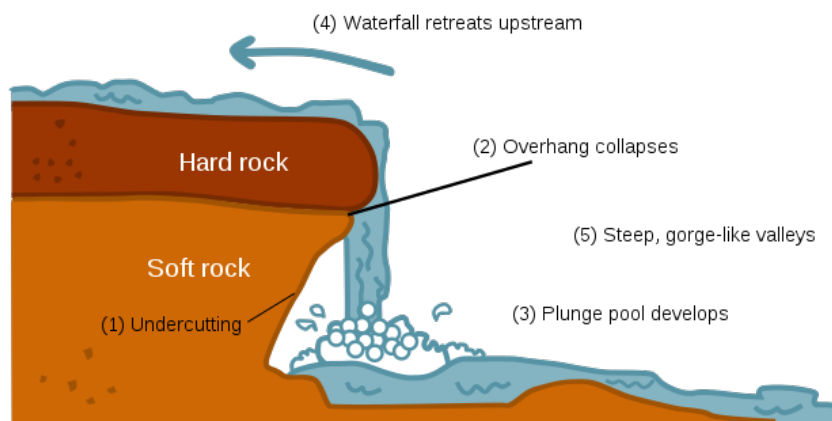
A worrying aspect of the spillway damage is that it was moving uphill. This is a typical sign of a failure known as headcutting (or undercutting), which is what happens when water flowing across a hard surface, falls onto a softer surface below. A simple illustration below explains this concept.

Figure 35. A typical example of undercutting failure. Source: Cradel, Wikimedia Commons (2009).

As in the above example, splashback from the newly created waterfall at the center of the main spillway caused it to erode in an upstream direction.

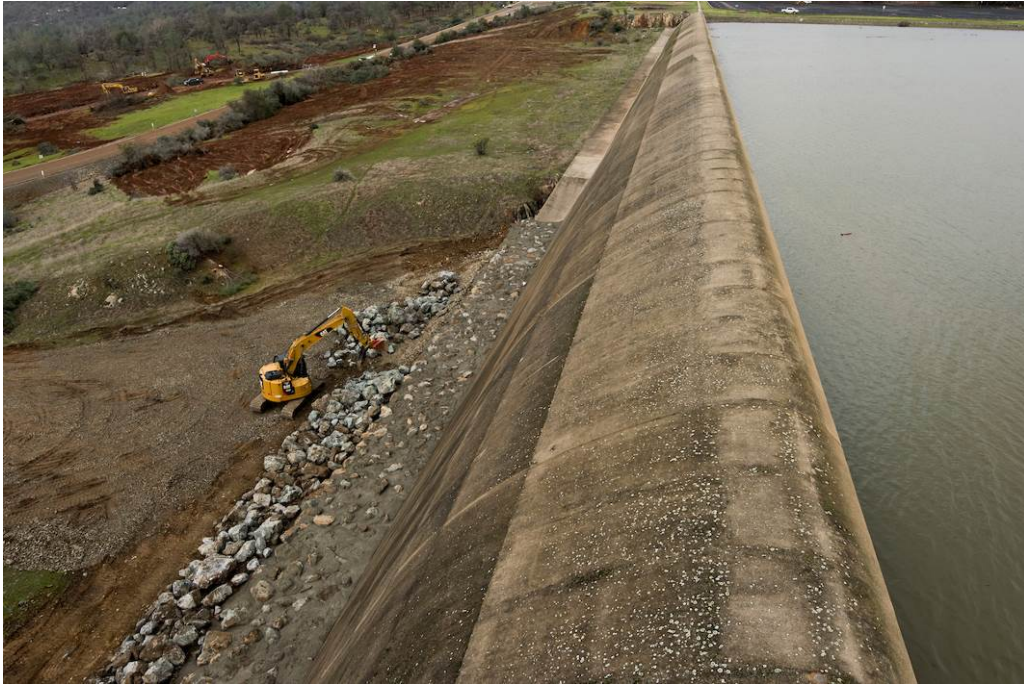
*Image 20. February 10th, 2017. Workers prepare the emergency spillway for use by placing large rocks at its foot.
Source: Brian Baer, DWR.*

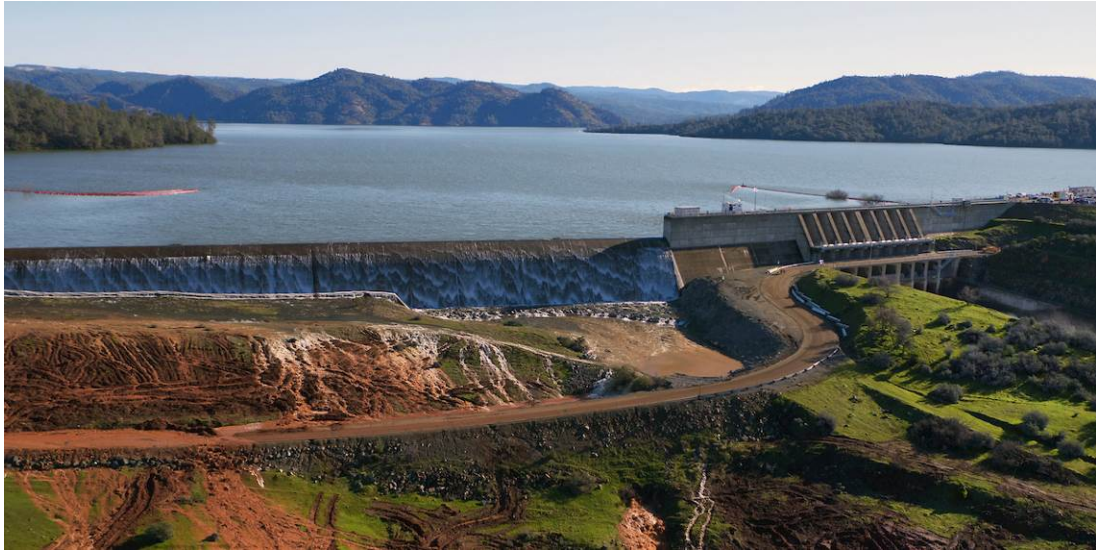
Image 21. February 11, 2017. Water flows over the Oroville Dam emergency spillway for the first time. Source: Zack Cunningham, DWR.

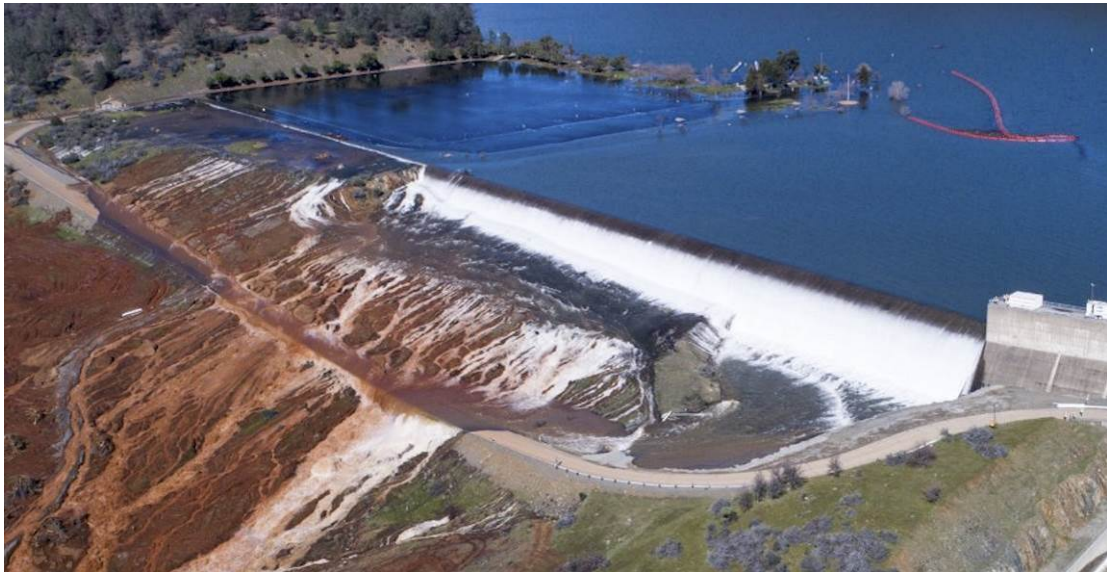
A rather interesting fact is that there is a parking lot just next to the emergency spillway, which is at a lower elevation, and thus is flooded by design whenever water pours over the weir. Furthermore, an access road located just below the structure was also subsequently flooded and quickly destroyed.

Image 22. February 11, 2017. Image of the flooded parking lot and access road located next to the emergency spillway. Source: Metabunk.org

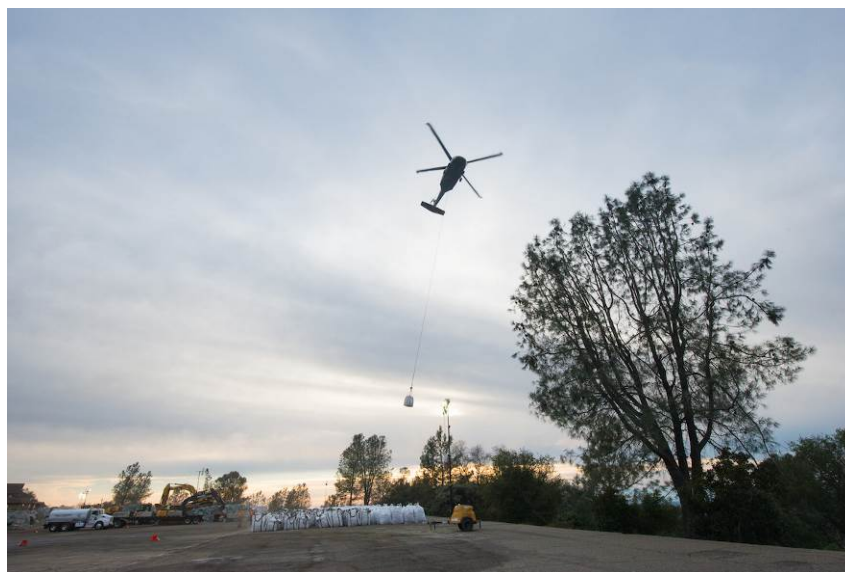
Image 29. A helicopter transports a bag of large rocks over to the emergency spillway. Source: Florence Low, DWR.

On February 13th, once flows over the emergency spillway stopped, an attempt to quickly remedy the downstream erosion began, in case it would have to be put to use again soon. Since the emergency spillway access road was destroyed, helicopters were used to transport large bags of rocks up to the parking lot next to the emergency spillway, and workers at the dam placed them below the auxiliary structure, covering any holes that had formed from the previous day's erosion, then pouring concrete on top to create a more solid base for potential future flows, which fortunately did not occur.

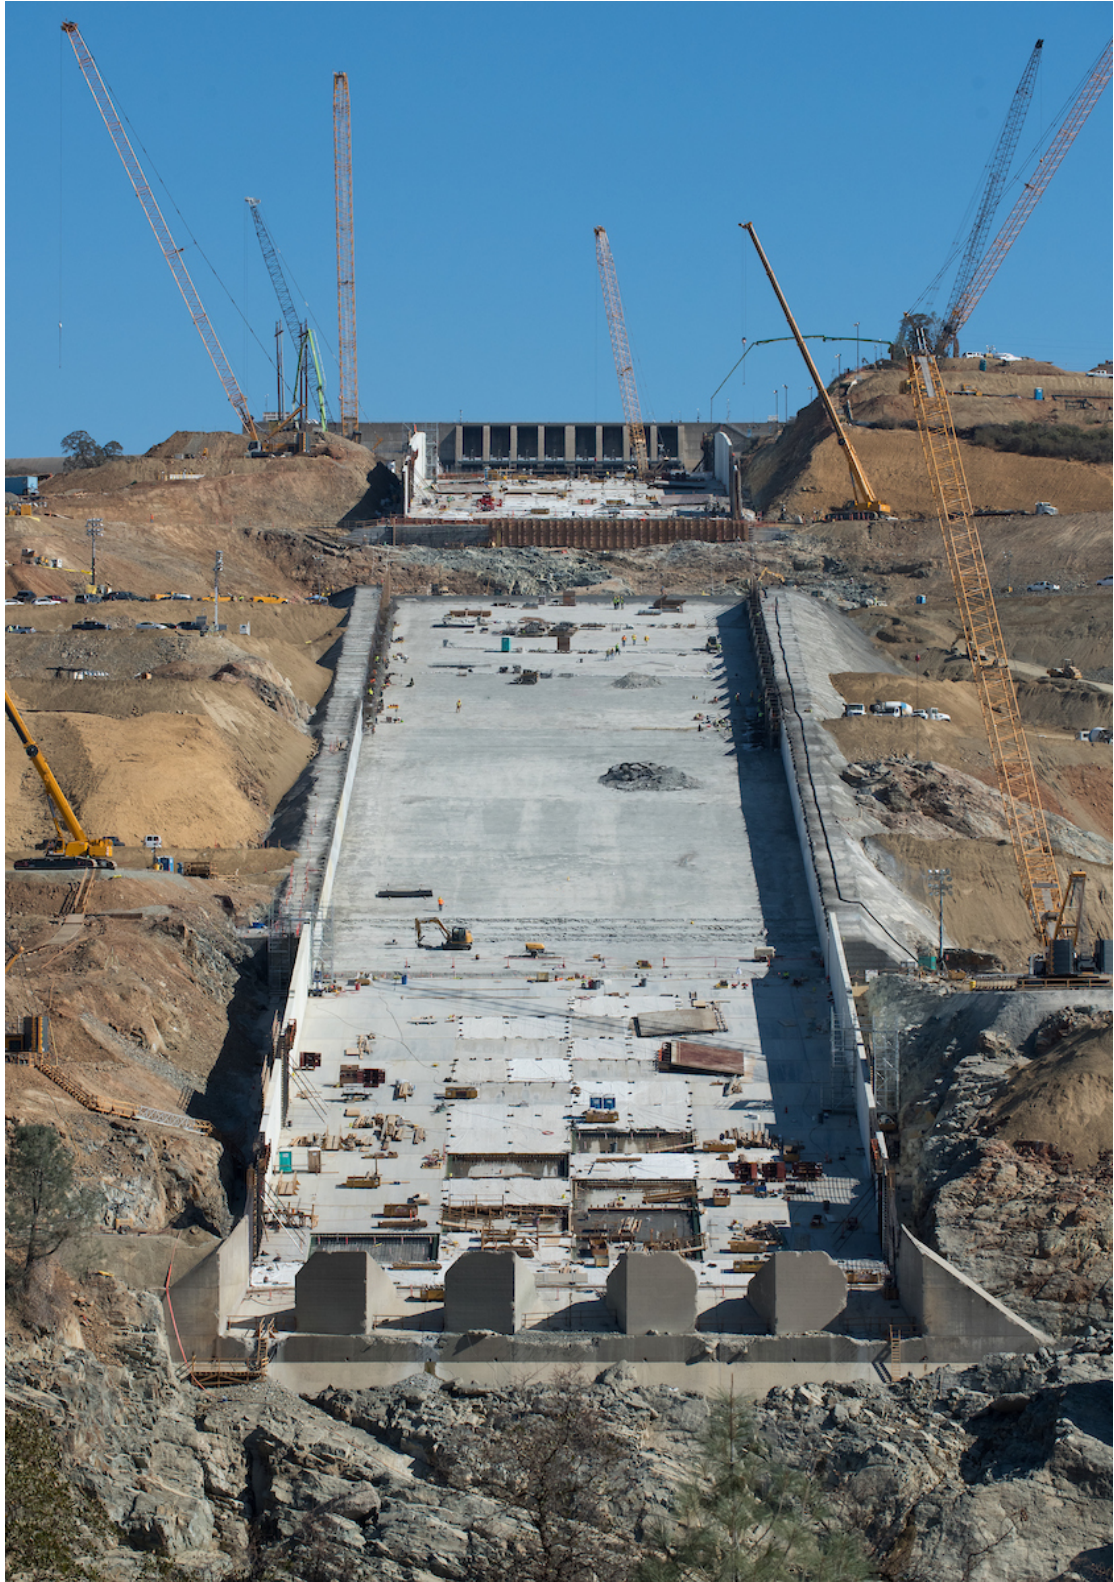
Image 33. October 13th, 2017. View of the Oroville Dam main spillway chute repair work. Source: Kelly M. Grow, DWR.

In the third and final phase, the upper segment of the main spillway is repaired, whereas the lower portion is replaced by a new one, built partly out of structural concrete and roller-compacted concrete (RCC). Estimated cost for the project is at around \$500 million, and is estimated to conclude by November. A recent image of the near completed spillway recently surfaced, shown below.

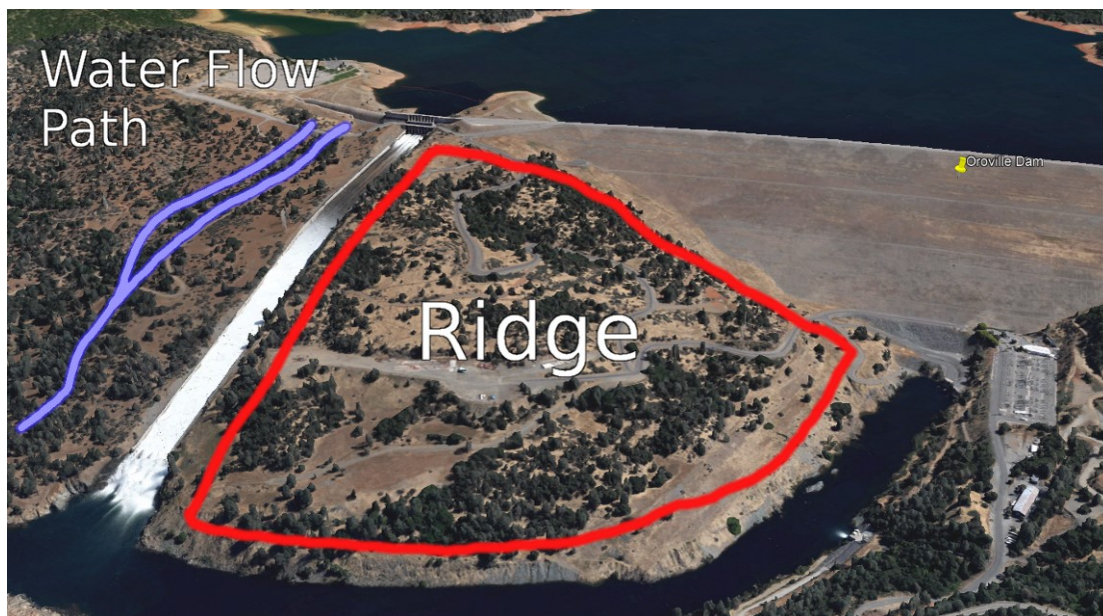
Image 35. A sketch of the ridge that protects the Oroville Dam main embankment from erosion. Adapted from Google Earth (2017).

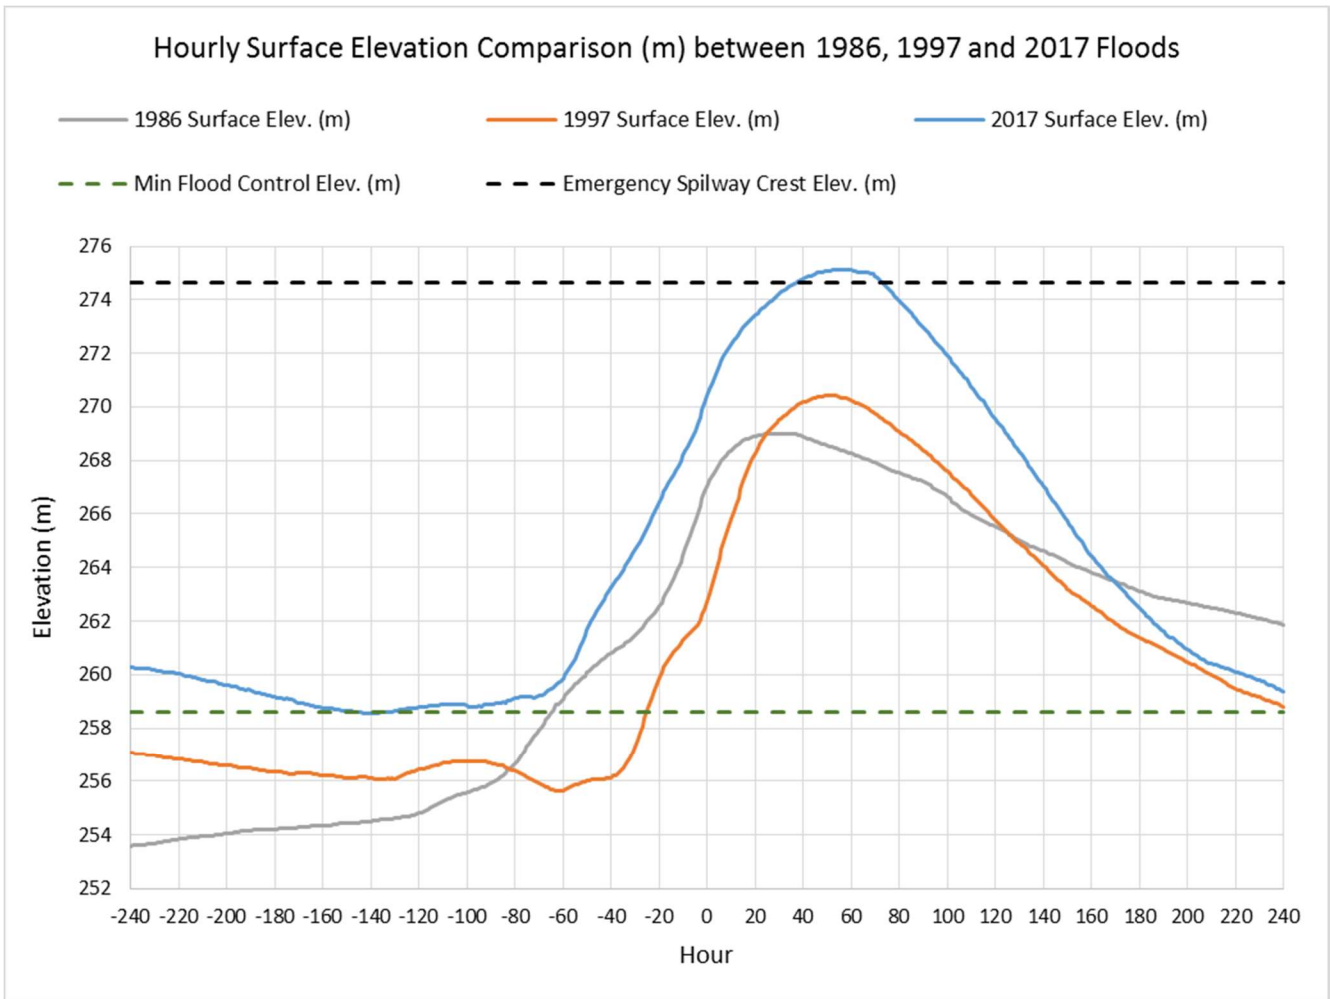
Figure 39. Hourly comparison of Oroville Dam reservoir surface elevations 10 days before and after the peak inflow of the 1986, 1997, and 2017 flood events.

Of course, no two flood events are the same and they all impact Oroville Dam in subtly different ways, but this comparison contains clues on what went wrong during the 2017 spillway incident.

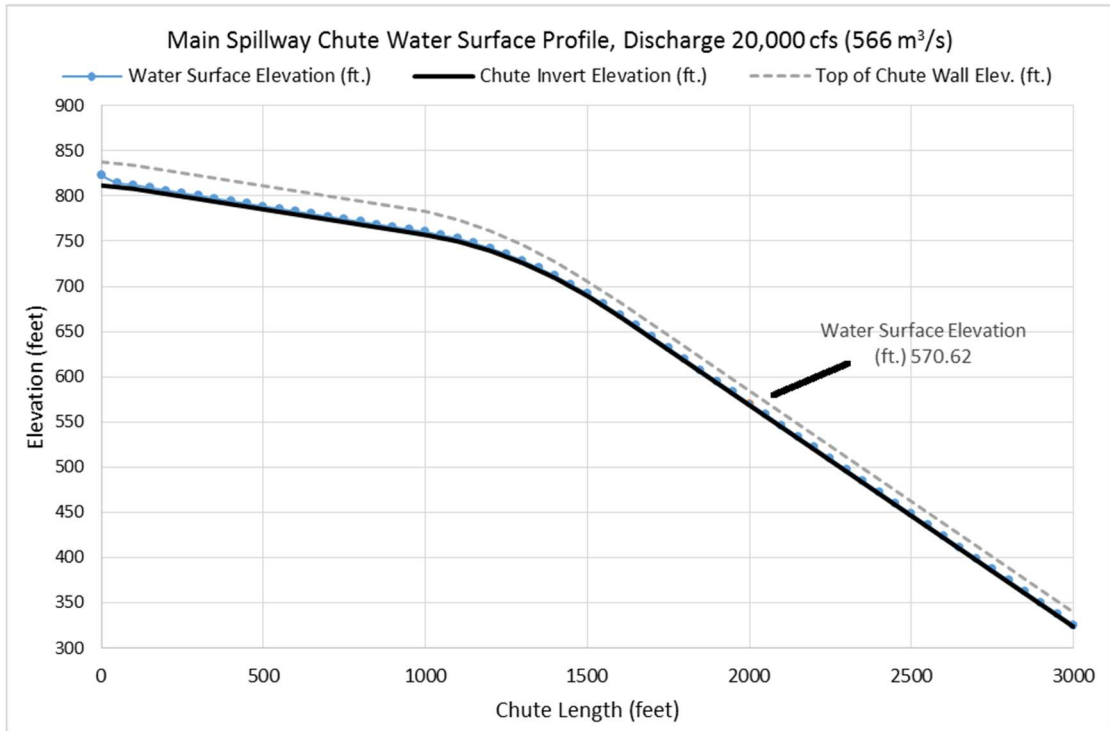
Figure 40. Oroville Dam main spillway chute water surface profile, discharge 566 m³/s (20,000 cfs)

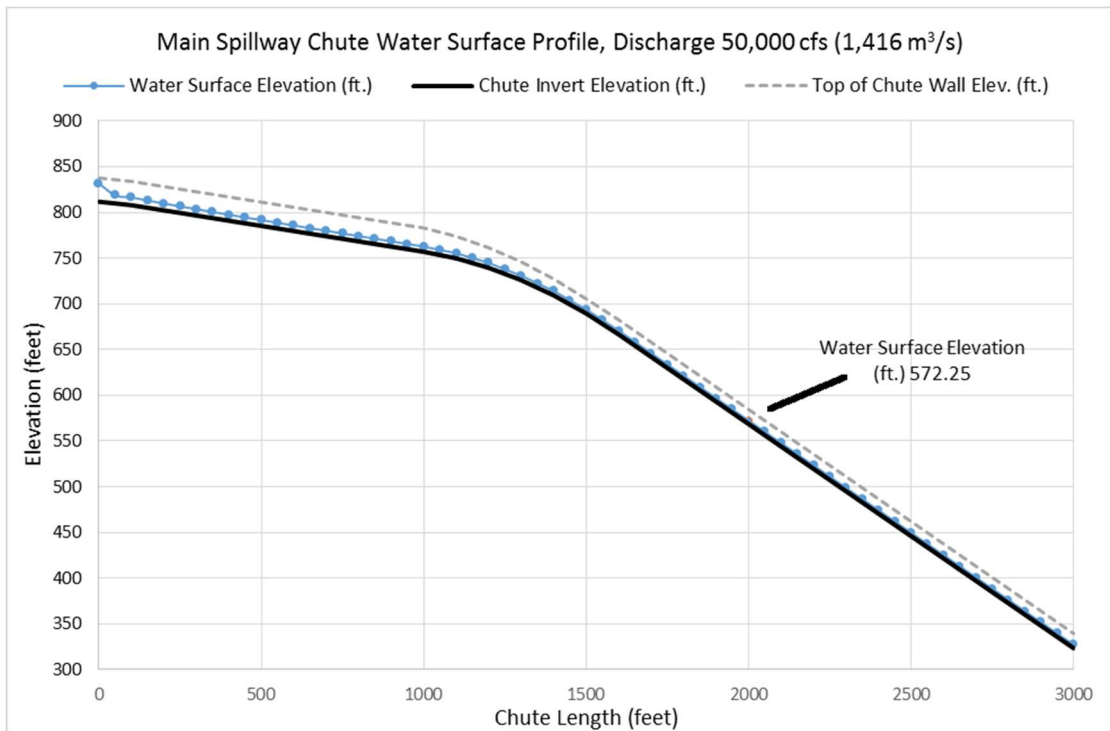
Figure 41. Oroville Dam main spillway chute water surface profile, discharge 1,416 m³/s (50,000 cfs)

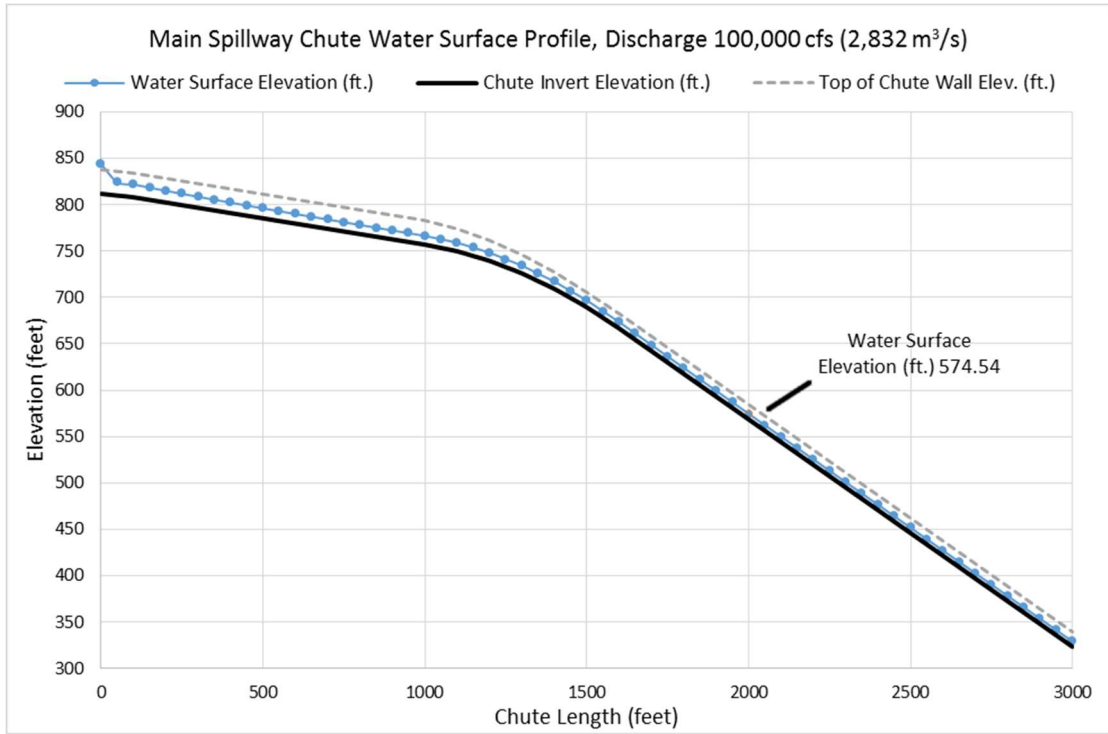
Figure 42. Oroville Dam main spillway chute water surface profile, discharge 2,832 m³/s (100,000 cfs)

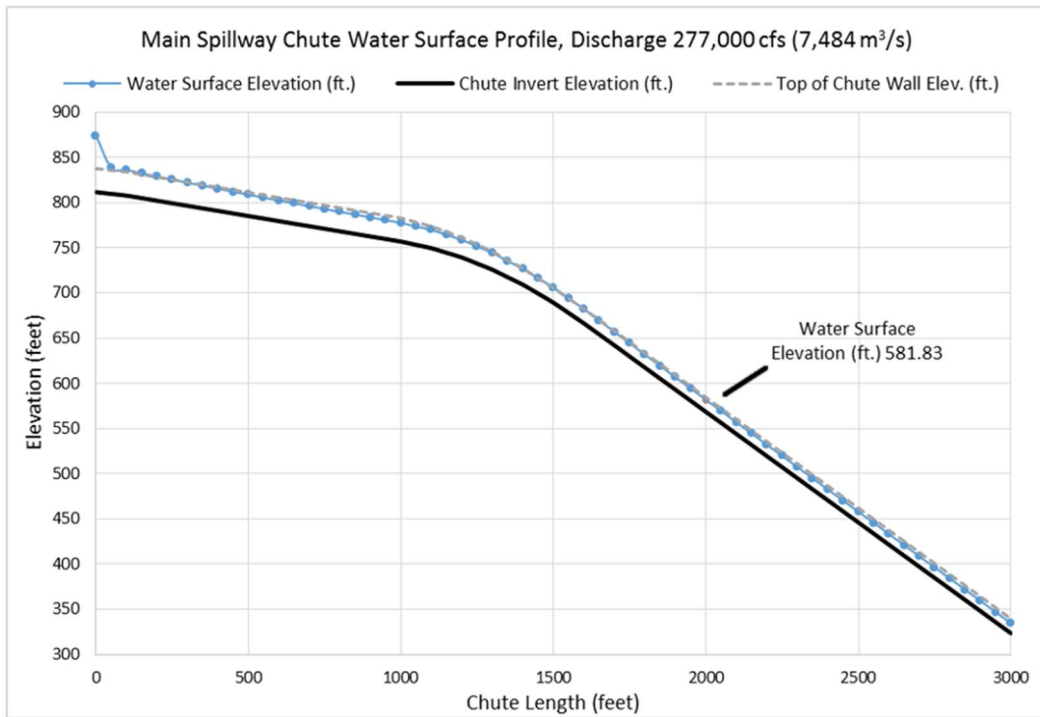
Figure 43. Oroville Dam main spillway chute water surface profile, discharge 7,484 m³/s (277,000 cfs)

From the chute flow analysis, it is clear that the initial assumption of critical flow depth at the chute's beginning does not negatively impact the results significantly, as due to the chute's design, flow depth quickly approaches normal depth with a standard S2 curve for supercritical flow (US Army Corps of Engineers, 2016). For low discharge profiles, normal depth is reached fairly quickly, and only when the

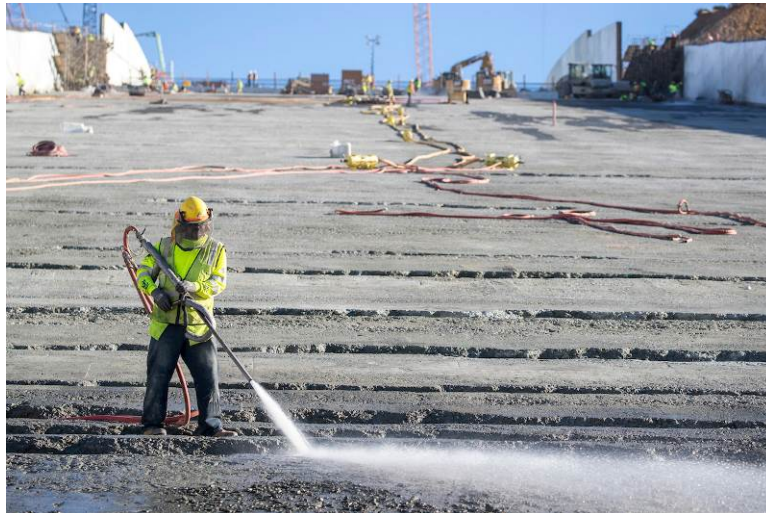
Image 41. October 25, 2017. A worker uses water and compressed air to clear the concrete floor of the new Oroville Dam spillway chute, in preparation for a new layer of RCC. The new structure is nearly complete.
