EGS – AGU – EUG Joint Assembly, Nice, France, April 2003

Session HS9 - Sediment dynamics and channel change in rivers and estuaries

Channel change and sediment movement after a major level drawdown at Kremasta reservoir, Western Greece

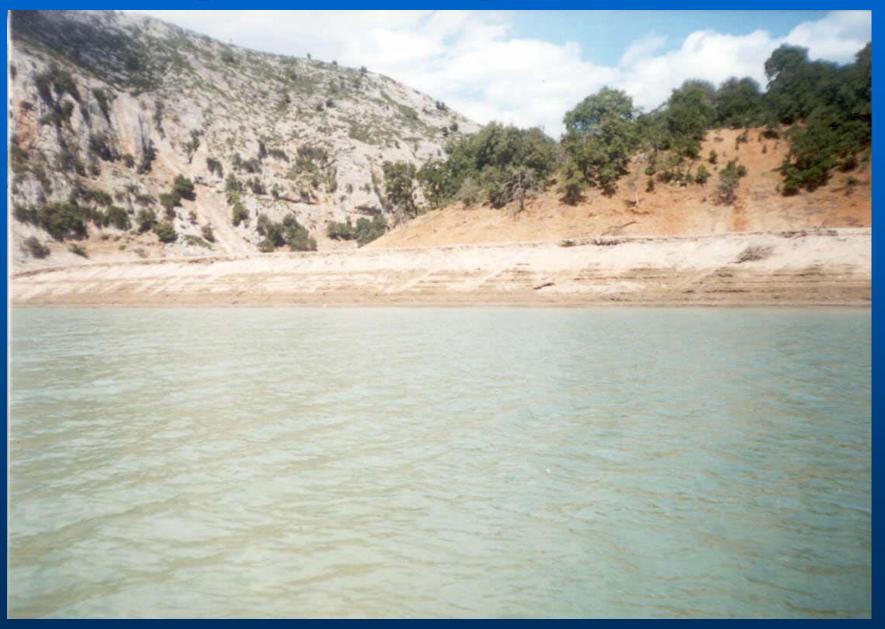
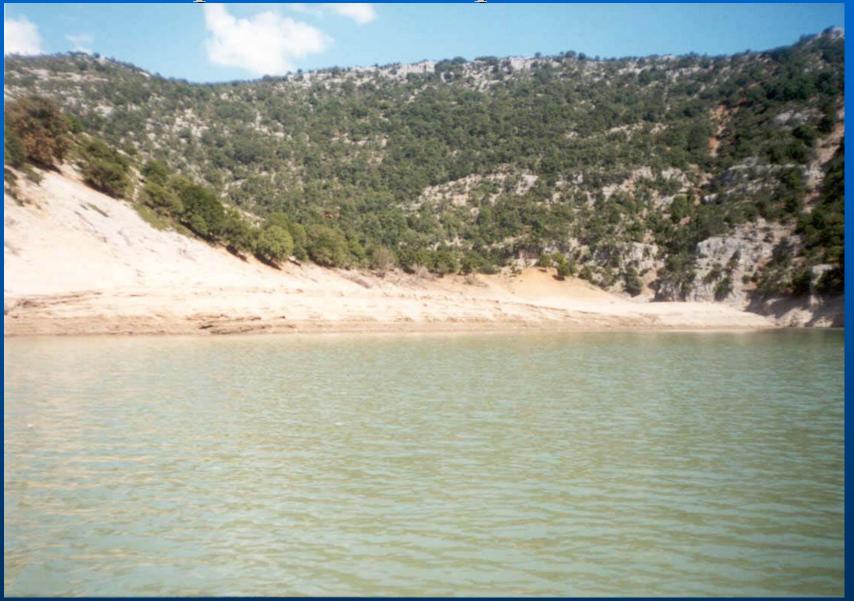
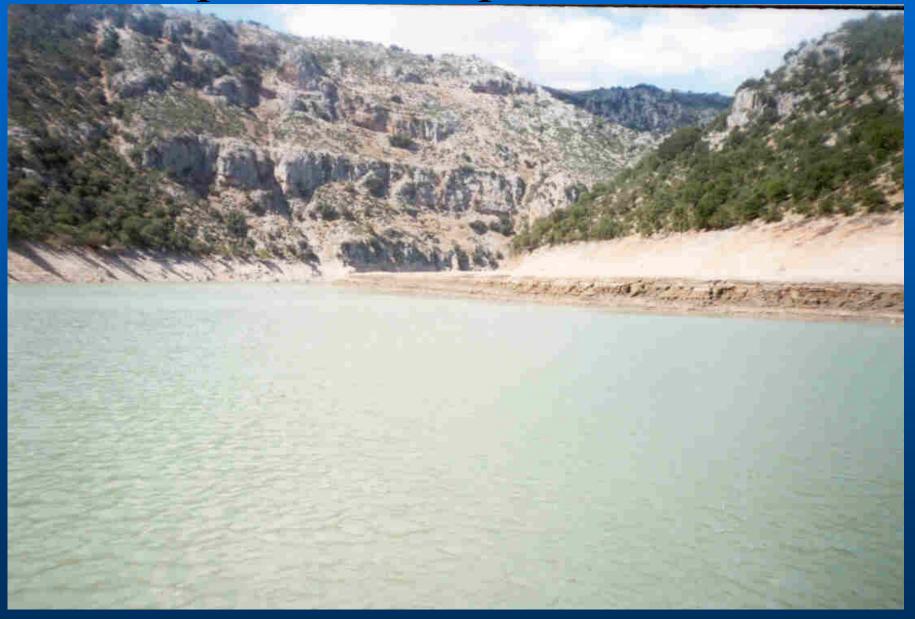
Understanding the erosion mechanism

- The recent reservoir drawdown is significant but far less from the maximum historical values
- The recent drawdown comes after seven consequent years with constantly high reservoir stages
- During the period of the last seven years, fine-grained fluvial sediments deposited forming the upper sedimentary layer
- Sedimentation continues after the hydrographic survey, as reservoir stages are still high, till the erosion eventually takes place
- At the maximum reservoir drawdown, the exposed sediment deposits were easily scoured, even from quite frequent river discharges
- It is possible, that a portion of the eroded sediments from core G2 transported downstream till the sedimentary core G1, which exhibits an increase of sediment depth since the hydrographic survey

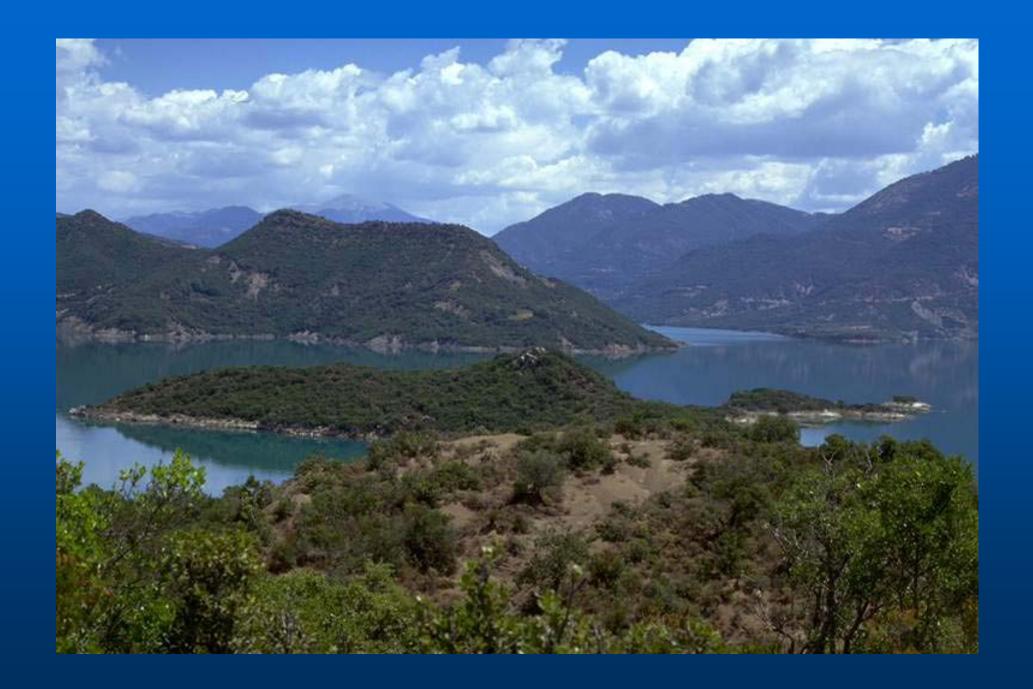
Reconstructing the sedimentation history of Kremasta reservoir

- Middle sediment strata exhibit poorly sorted stratification. The extremely frequent stage drawdowns do not support stable depositional environment
- The downstream sedimentary core exhibit less uniform sorting, mainly because of the influence of the tributary Granitsiotis River, which supplies sediment from a nearby watershed, additional to sediment transported from the upstream part of Acheloos River.
